Electrically Induced Bearing Damage (EIBD)
aka Shaft Currents
aka Electrical Discharge Machining (EDM)
Identification, Cause, Effect, Prevention, and Solutions

Written by: Garrett Sandwell, MET, CVA, ASNT 3

Original article: 2002 with revisions up to 2022

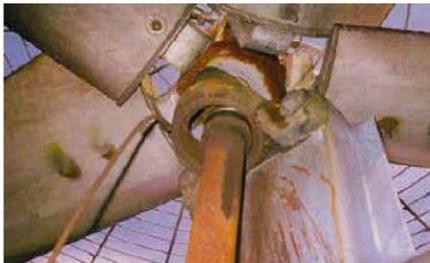
Fig 1. The failure was due to defective bearing.

Solution to Fig. 1 Replaced both Fan Bearings & New Motor Required.

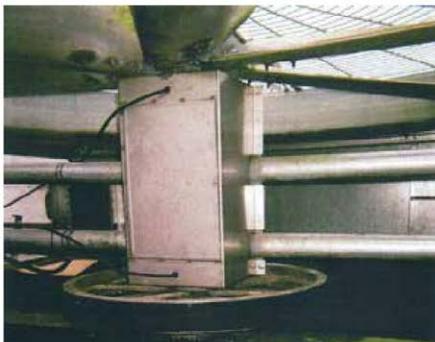
Fig 2. The stainless steel guard helps prevent moisture contamination in cooling tower fan bearings (a very common problem).

Solution to Fig. 2 The Guard has prolonged the Life Span of the Fan Bearings from 3 years to over 14 years.

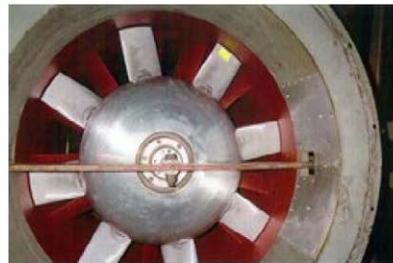
Fig 3. A new fan was installed due to a complete failure of the original.

Solution to Fig. 3 Installed Brand New Controllable Pitch Fan & Repaired Motor.

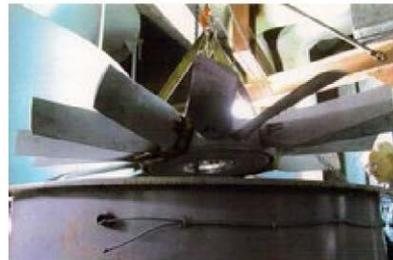
Fig 4. Shows a 200HP motor and fan repair/replacement.

Solution to Fig. 4 Replaced the Old Motor based on 20 years of running time and Completed Variable Pitch in Motion Fan Maintenance.

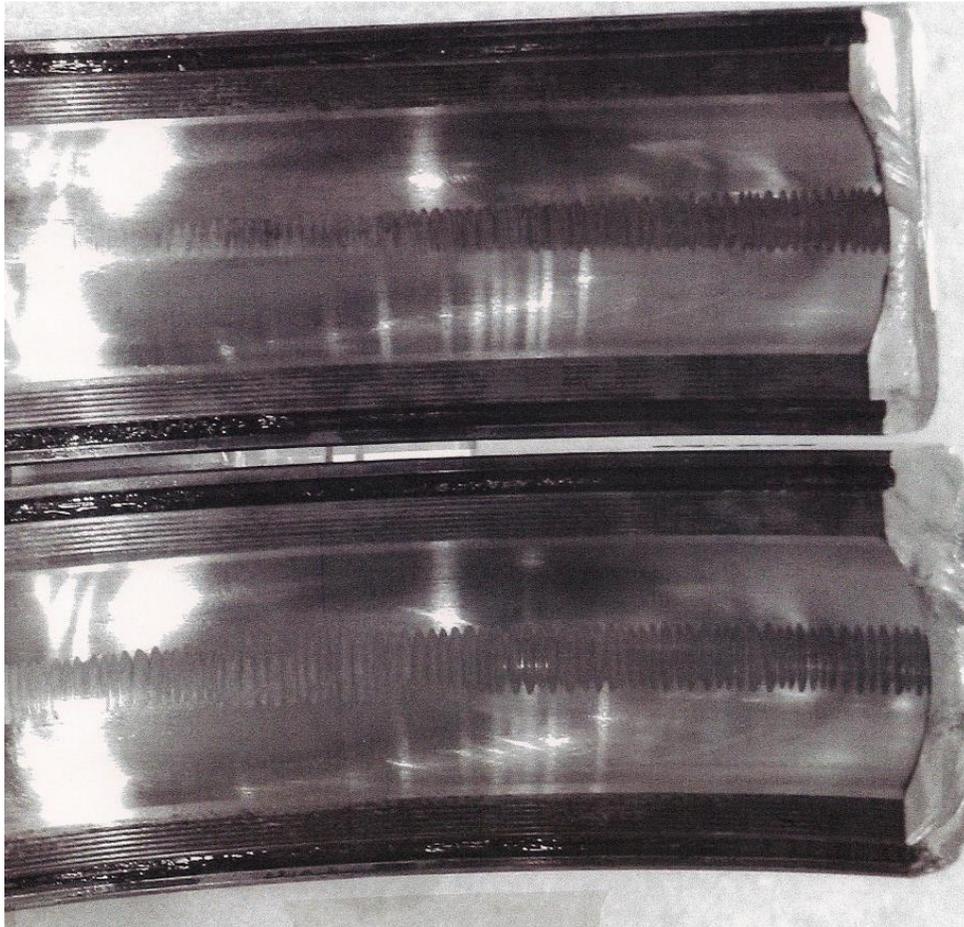
Figure 4: The bearing race shown in this photo was found in the advanced stage of fluting. Vibration spectrum data for this bearing can be reviewed on pages 16 – 19. See scanning electron microscope (SEM) images for the above bearing race on pages 14 and 15.

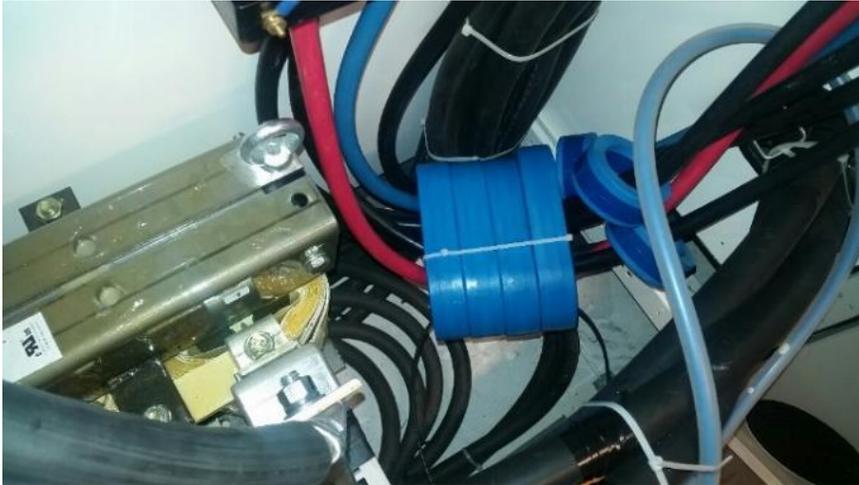
Figure 1 = 350 HP VFD - Rotary Screw Compressor

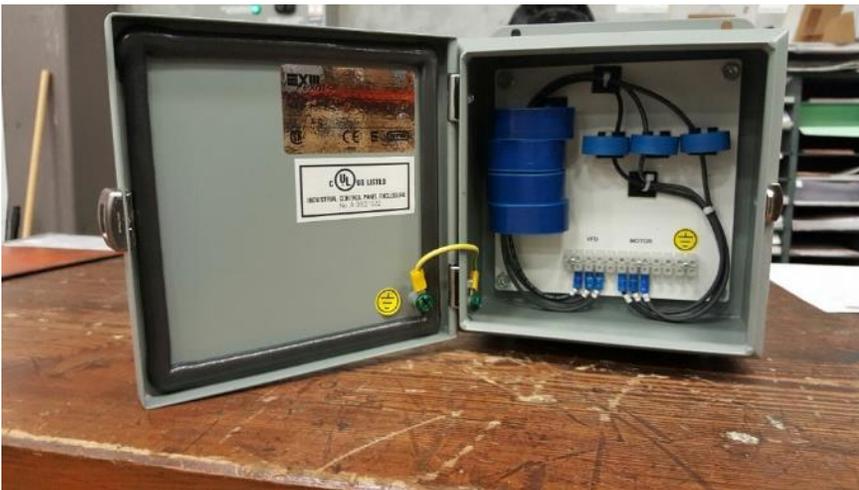
Figure 3 = 10 HP VFD/Junction Box - AHU

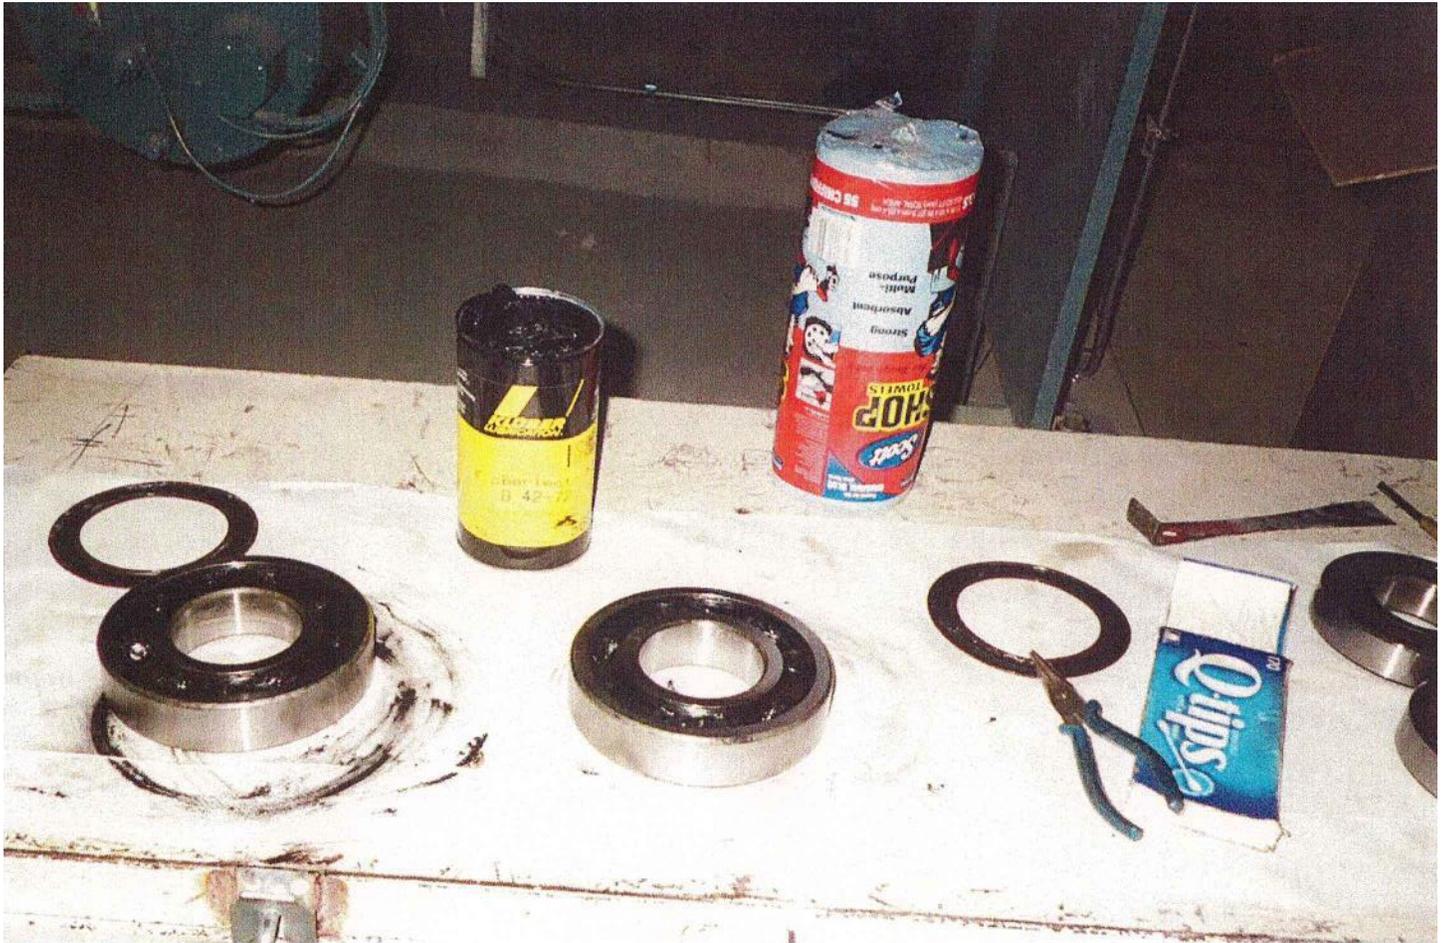
“EIBD” – One Solution Applied = Use Sealed Bearings, clean out factory grease and pack with Electro conductive Grease.

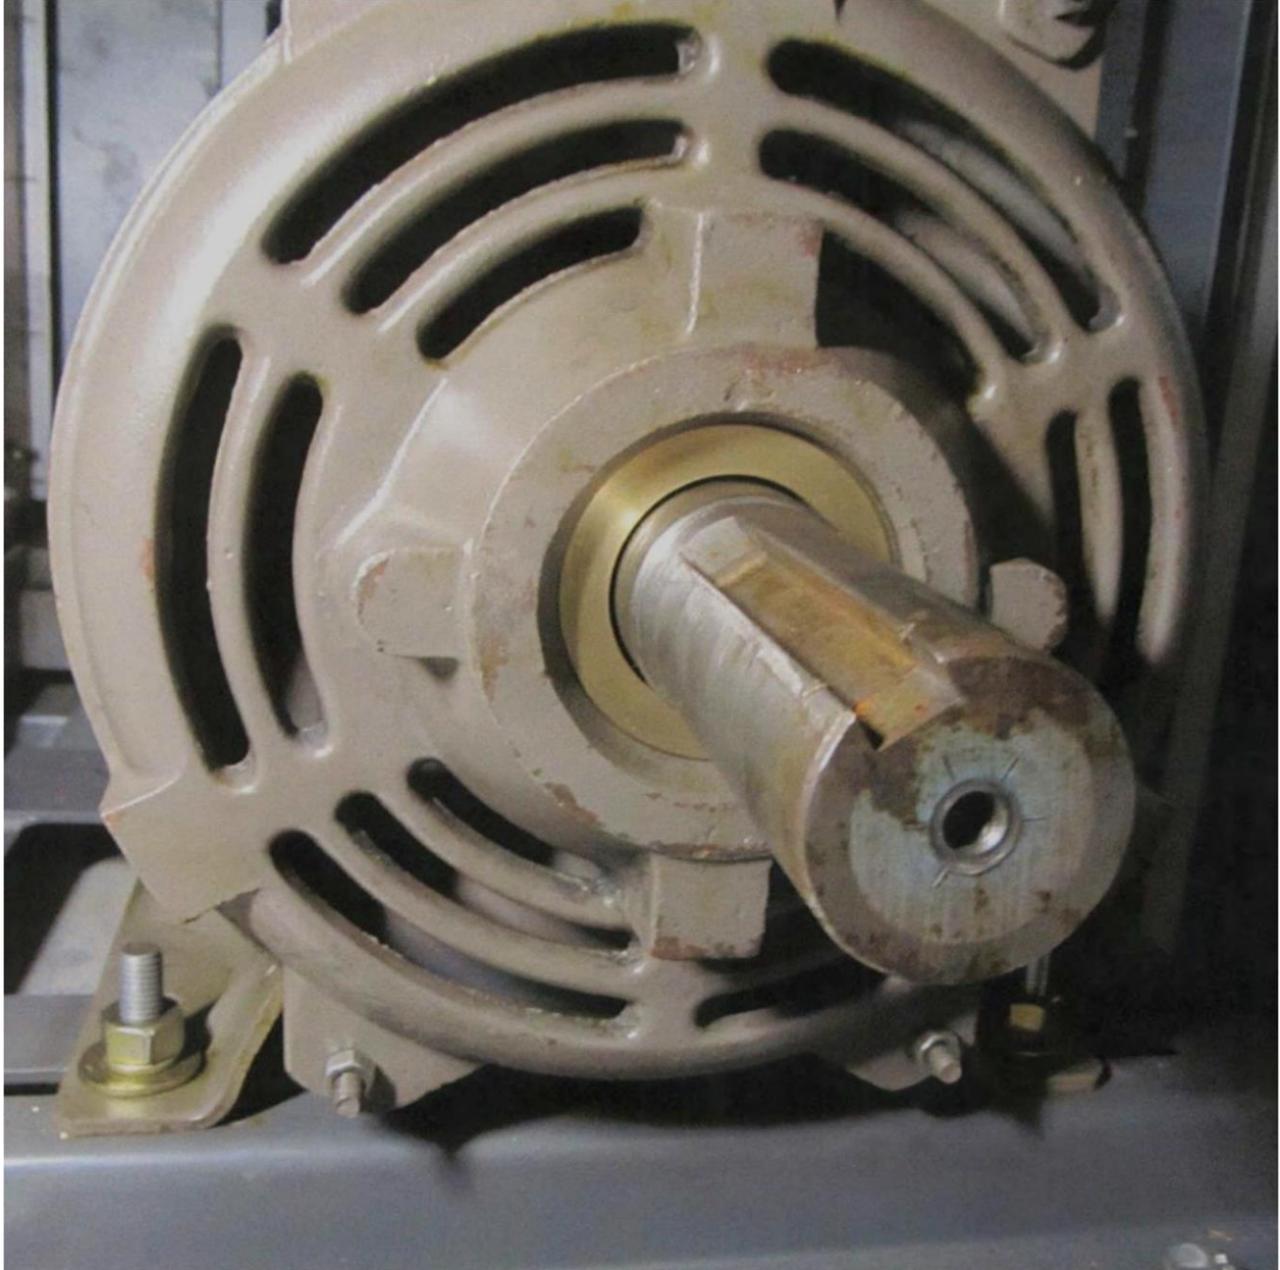
INPRO-SEAL MGS SEAL INSTALLED ON A MOTOR DRIVE END

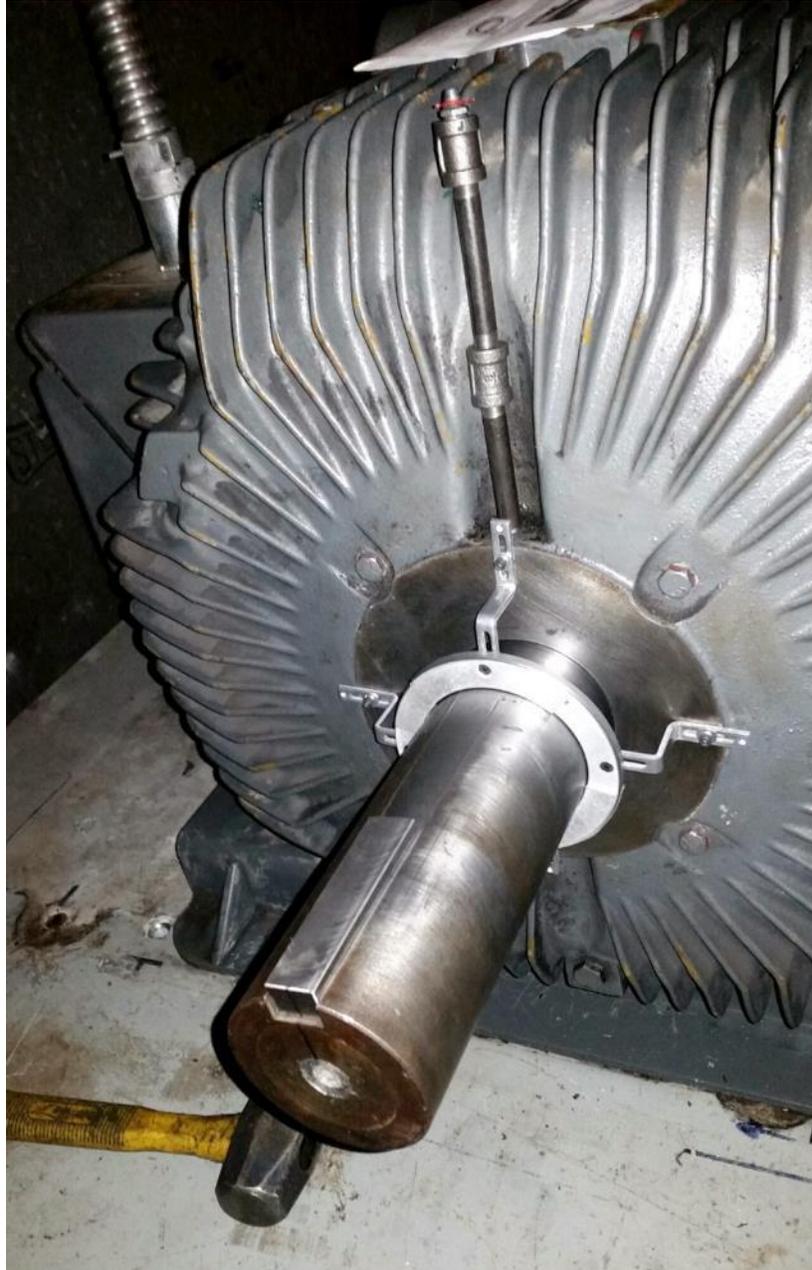
AEGIS SGR SEAL INSTALLED ON A MOTOR DRIVE END

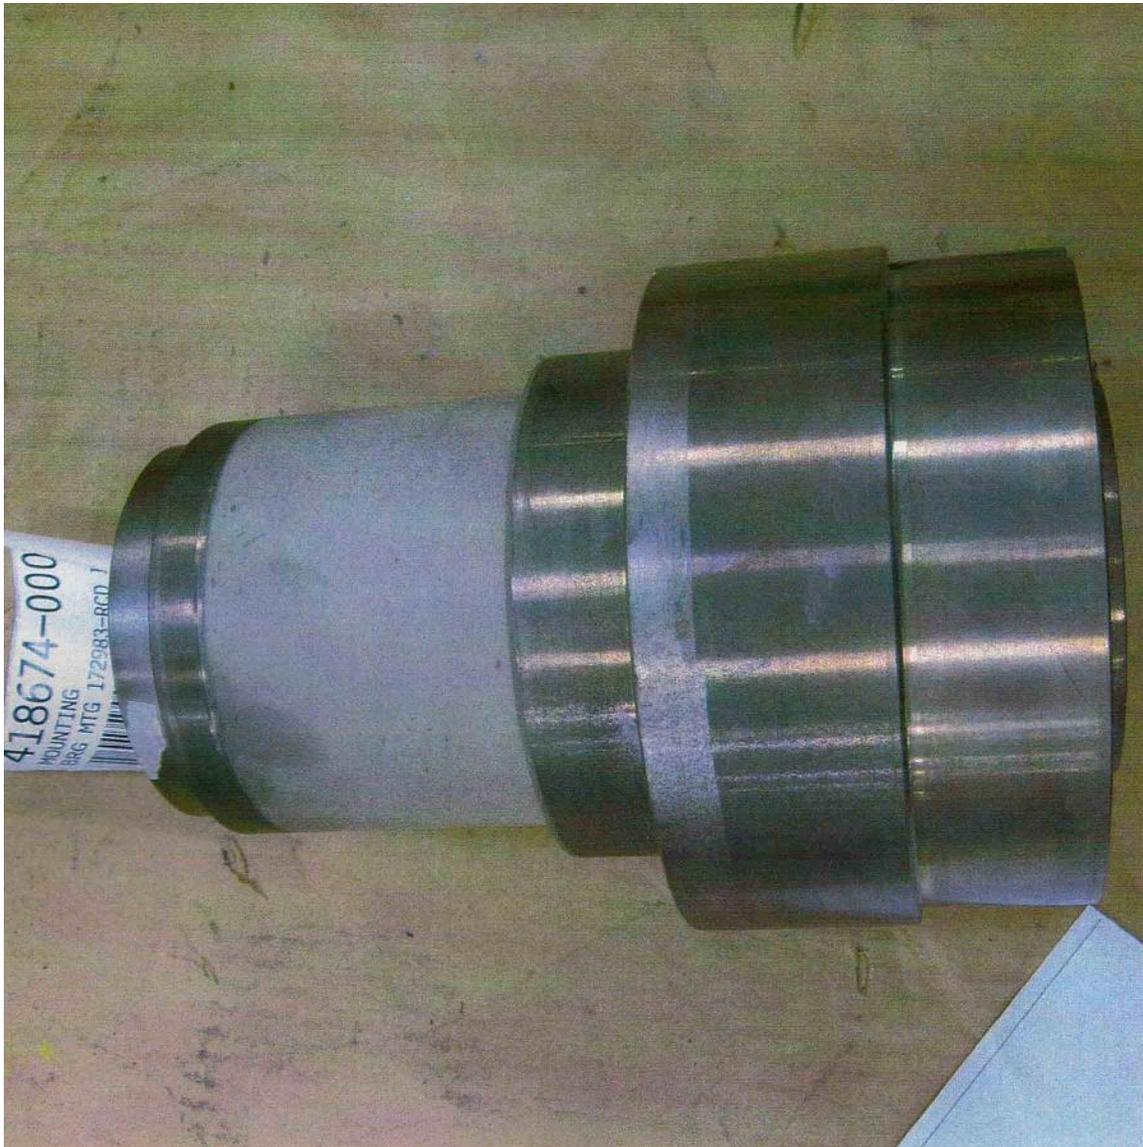
THE PHOTOS ATTACHED ARE AN ACTUAL APPLICATION EXAMPLE OF INSULATING A MOTOR BEARING.

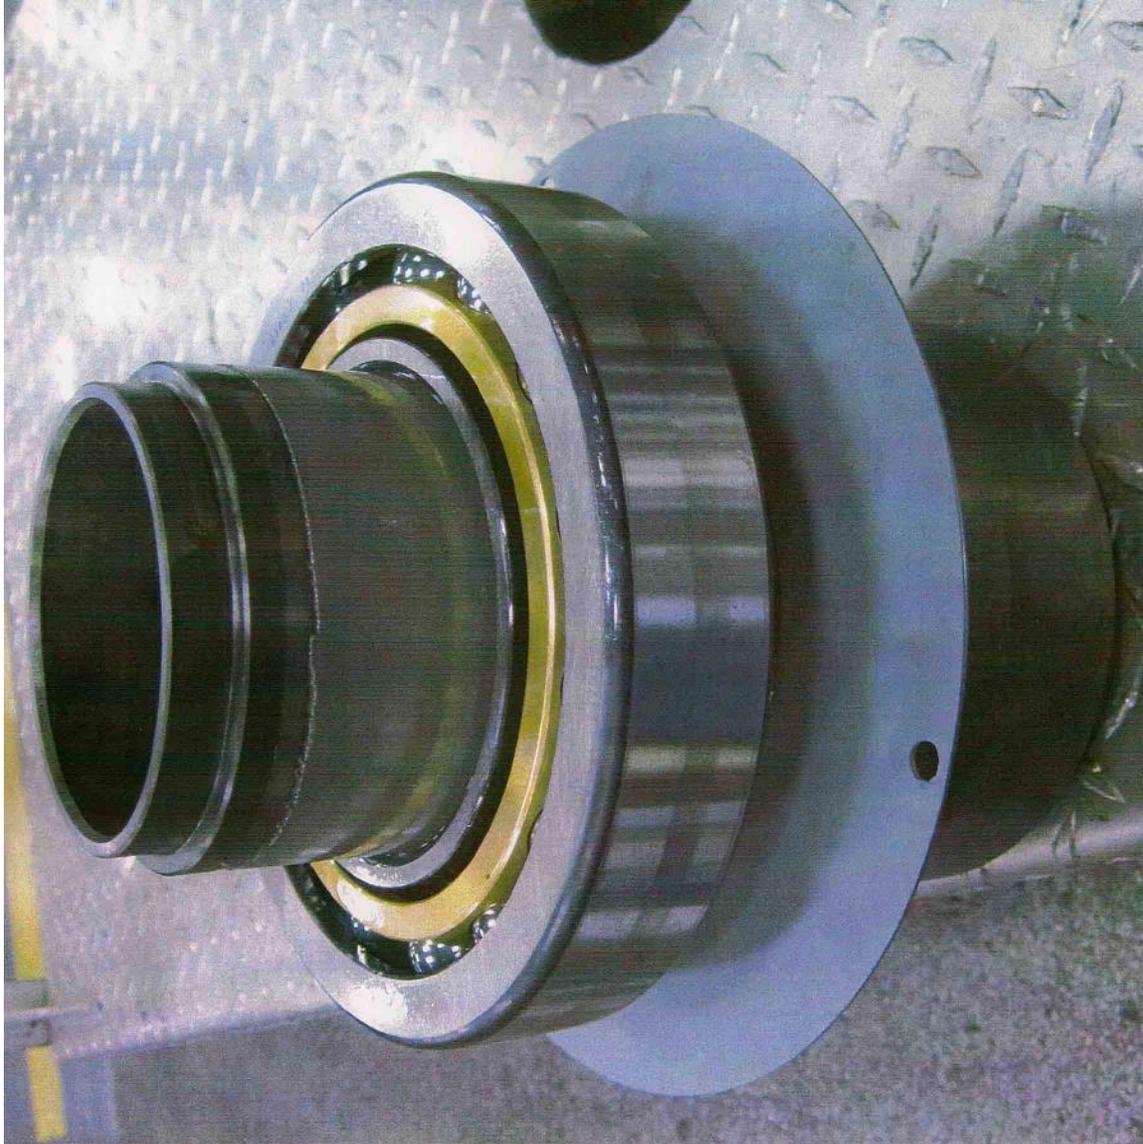
THE PHOTOS ATTACHED ARE AN ACTUAL APPLICATION EXAMPLE OF INSULATING A MOTOR BEARING.

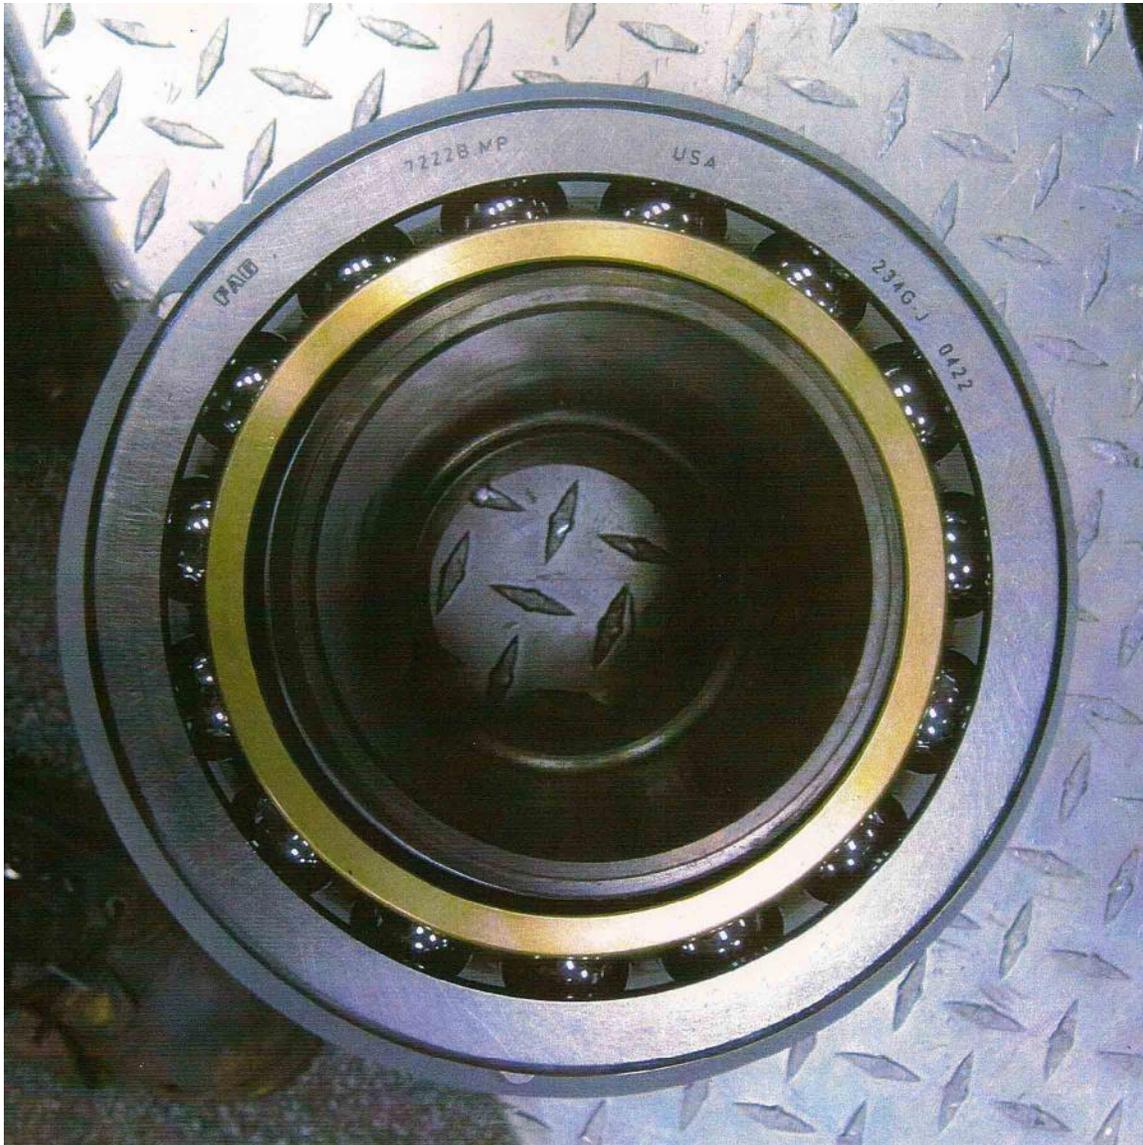
THE PHOTOS ATTACHED ARE AN ACTUAL APPLICATION EXAMPLE OF INSULATING A MOTOR BEARING.

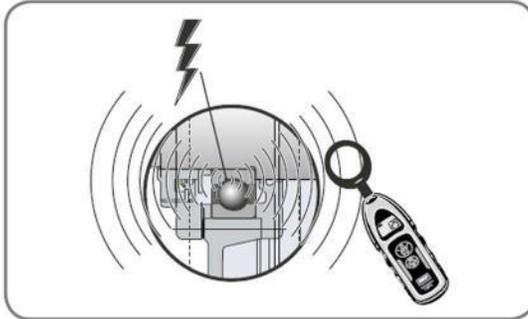
2. Use the TKED 1 as close as possible to the bearing location to perform a detection. Avoid the vicinity of the cables and the Variable Frequency Drive (VFD) controller, which could induce some disturbances:
