SERIOUS SERVICE®
Professional Machinery Health Care
(Fan Doctor®)

Installation of CoolBlue Inductive Absorbers and Common Mode Current Measurement – Parc Riviera Pump Station

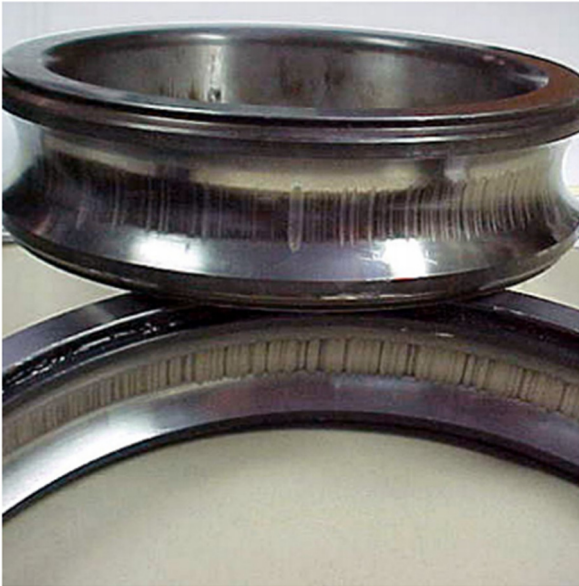
Typical bearing fluting caused by EDM

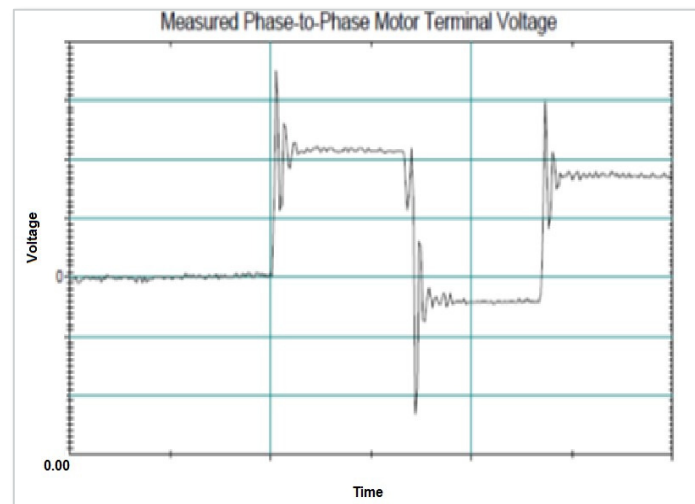
Each pulse in a PWM system is not a clean square pulse. Each Rise and Fall of the pulse has an over shoot or transient over-voltage. This over-voltage phenomenon is also known as "Reflected Wave", "Transmission Line Effect" or "Standing Wave".

The per unit overvoltage magnitude is dependent upon drive-cable-motor circuit dynamics defined by drive output voltage magnitude and rise time, cable surge impedance characteristics, motor surge impedance to the pulse voltage, cable length and spacing of the train of pulses by the PWM modulator.

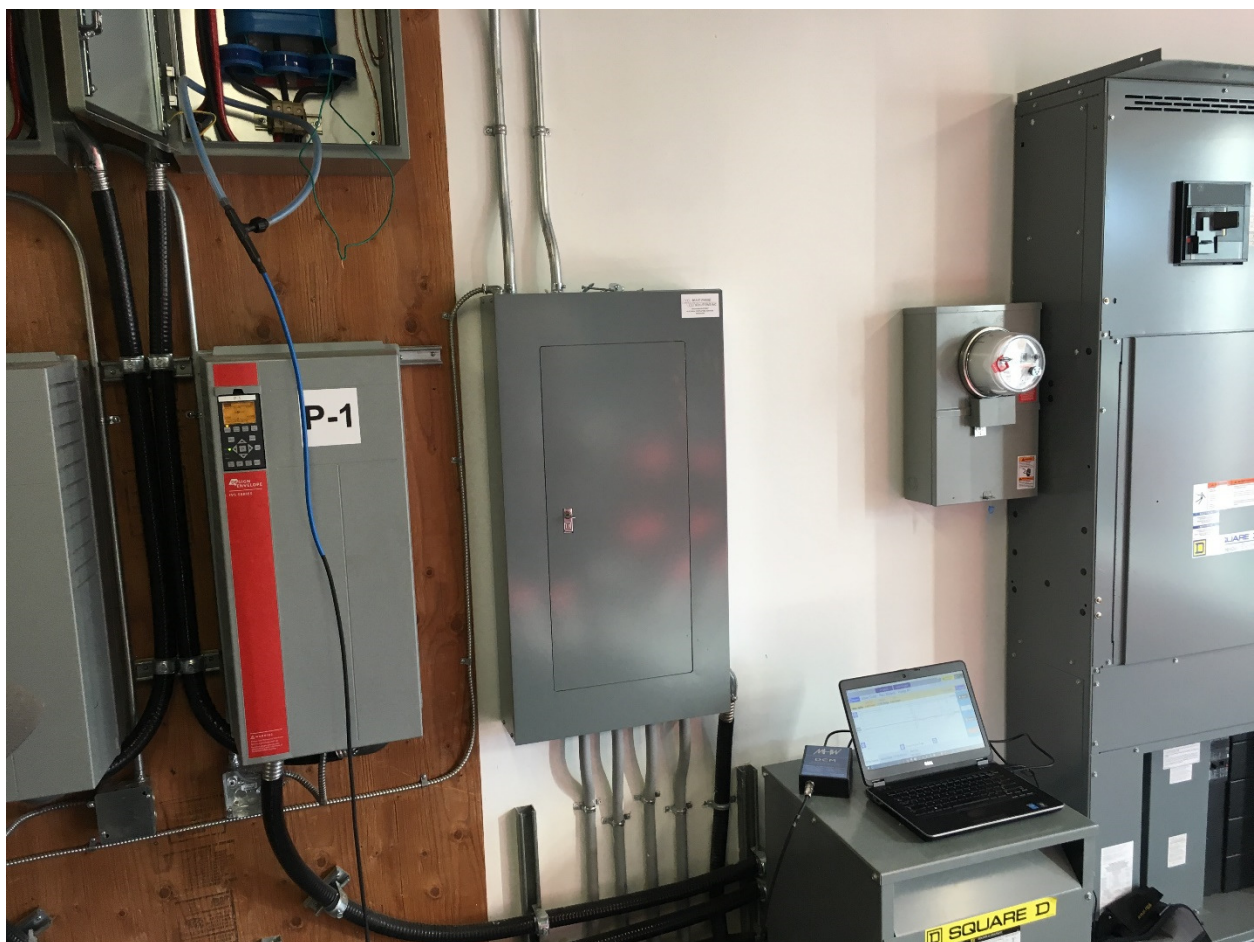
The simplest and safest way to measure common mode current is with a flexible, clip-around, Rogowski coil. This method is used to measure high frequency destructive common mode currents in motor drives . . . high frequencies produced by motor drive IGBT's in the kHz up to several MHz's.

The high frequency Rogowski coil simply connects around the 3 power phases of cable going from the drive to the motor to measure common mode current. If multiple cables per phase, coil would still go around all cables. The output of the Rogowski coil connects to the DCM 100, and measures the common mode current.

Simply power down, place the Rogowski coil around 3 phases of power.

Power up system. Measure current.

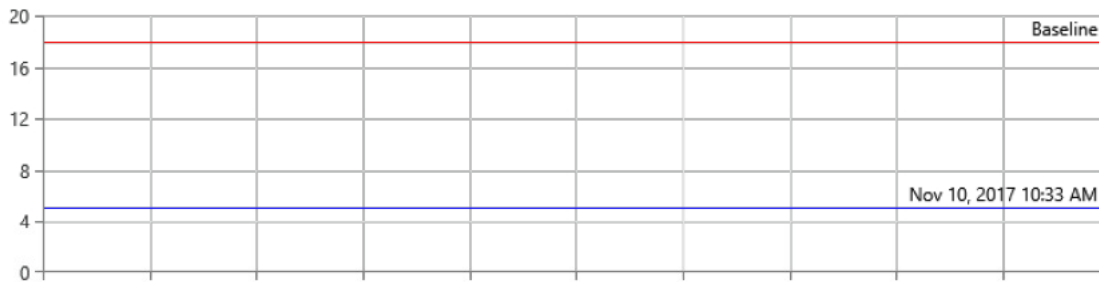
<u>Date Recorded</u>	<u>Peak Spike</u>	<u>Reduction</u>	<u>Avg Spike</u>	<u>Reduction</u>
Nov 10, 2017 10:27 AM	17.92 Amps	BASELINE	3.91 Amps	BASELINE
Nov 10, 2017 10:33 AM	5.07 Amps	-72%	1.86 Amps	-52%

BASELINE DATA

Peak Current Spike: 17.92 Amps

- Common mode peak currents measured since the installation of CoolBlue® Inductive Absorbers and NALA differential line absorbers are well below the recommended levels
- Peak Current reductions are as follows
 - Pump #1 – 72%
 - Pump #2 – 73%
 - Pump #3 – 59%
 - Pump #4 – 63%
- As well as the amplitude of the current being reduced, the frequency observed has slowed down significantly, and subsequent ringing in the lines after the peak spikes has almost been eliminated

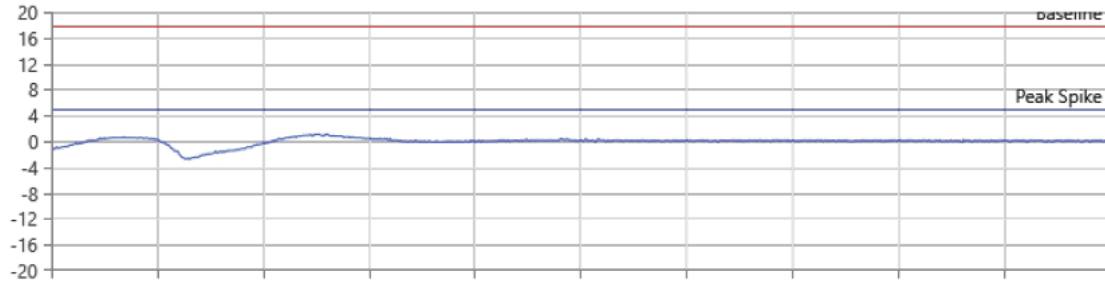
Peak Current Spike: 5.07 Amps (-72%)

Recorded: Nov 10, 2017 10:33 AM

Average Current Spike: 1.86 Amps (-52%)

Time/Div: 5 μ s

Notes: CoolBlue Installed

CoolBLUE® Inductive Absorbers (all lines): 4 x M-302 -or- 4 x M-116

NaLA® Line Absorbers (per line): 1 x M-613

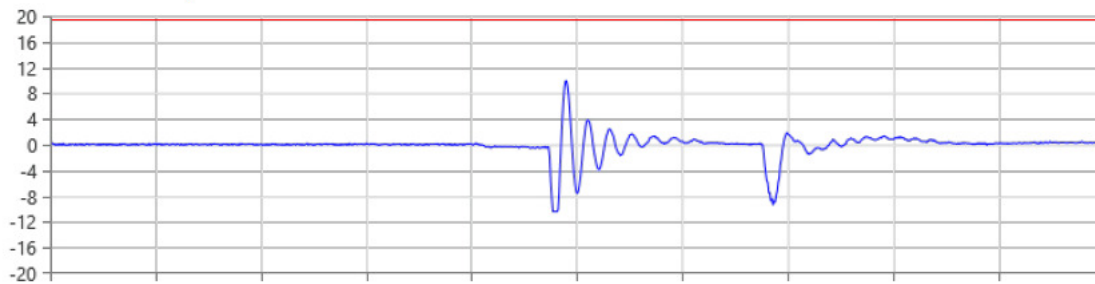
BASELINE DATA

Peak Current Spike: 19.62 Amps

Recorded: Nov 10, 2017 10:36 AM

Average Current Spike: 4.19 Amps

Time/Div: 5 μs

Notes: CoolBlue Defeated

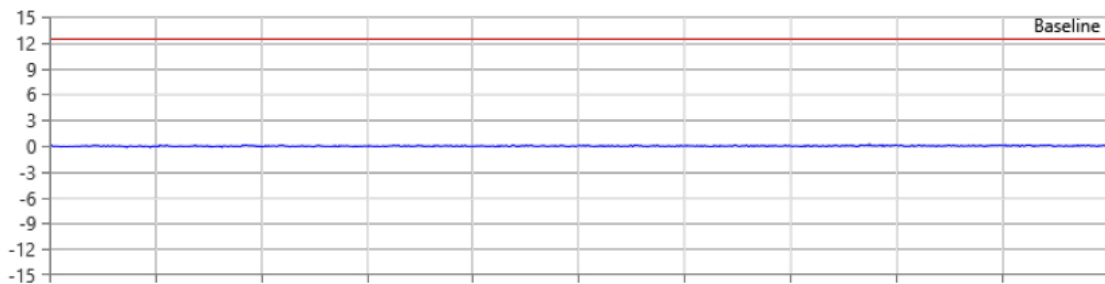
BASELINE DATA

Peak Current Spike: 12.57 Amps

Recorded: Nov 10, 2017 10:46 AM

Average Current Spike: 2.60 Amps

Time/Div: 5 μ s

Notes: CoolBlue Defeated

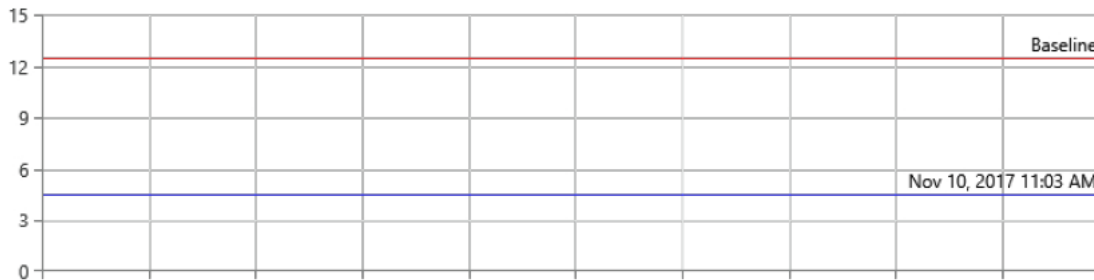
Date Recorded	Peak Spike	Reduction	Avg Spike	Reduction
Nov 10, 2017 11:01 AM	12.53 Amps	BASELINE	5.05 Amps	BASELINE
Nov 10, 2017 11:03 AM	4.59 Amps	-63%	1.87 Amps	-63%

BASELINE DATA

Peak Current Spike: 12.53 Amps
