**VIBES Corp<sup>®</sup>**

**SERIOUS SERVICE<sup>®</sup>**  
*Professional Machinery Health Care*  
**(Fan Doctor<sup>®</sup>)**

# Introduction to **VIBES Corp.**<sup>®</sup>

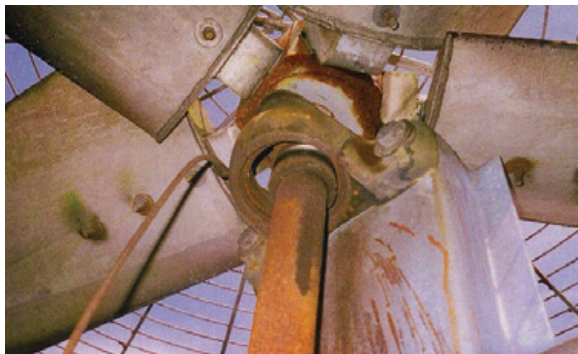
*Fig. 1*

Fig 1. The failure was due to defective bearing.

**Solution to Fig. 1** Replaced both Fan Bearings & New Motor Required.

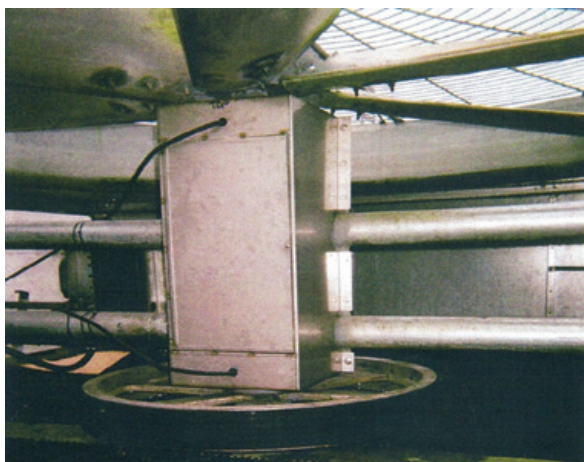
*Fig. 2*

Fig 2. The stainless steel guard helps prevent moisture contamination in cooling tower fan bearings (a very common problem).

**Solution to Fig. 2** The Guard has prolonged the Life Span of the Fan Bearings from 3 years to over 14 years.

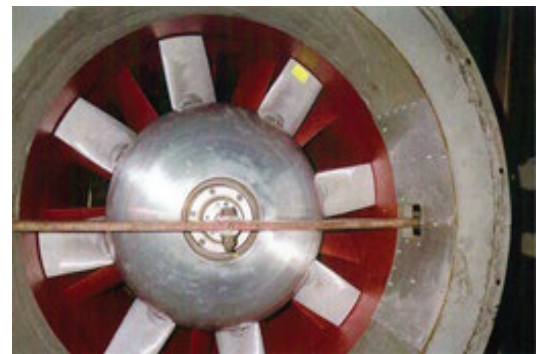
*Fig. 3*

Fig 3. A new fan was installed due to a complete failure of the original.

**Solution to Fig. 3** Installed Brand New Controllable Pitch Fan & Repaired Motor.

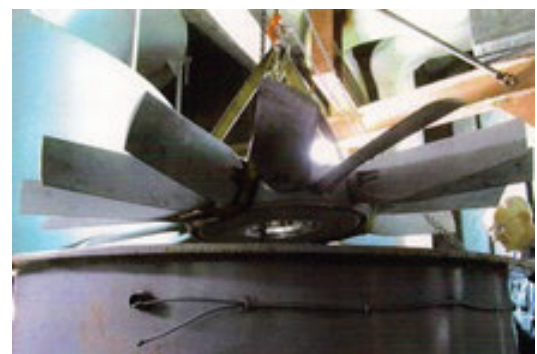
*Fig. 4*

Fig 4. Shows a 200HP motor and fan repair/replacement.

**Solution to Fig. 4** Replaced the Old Motor based on 20 years of running time and Completed Variable Pitch in Motion Fan Maintenance.

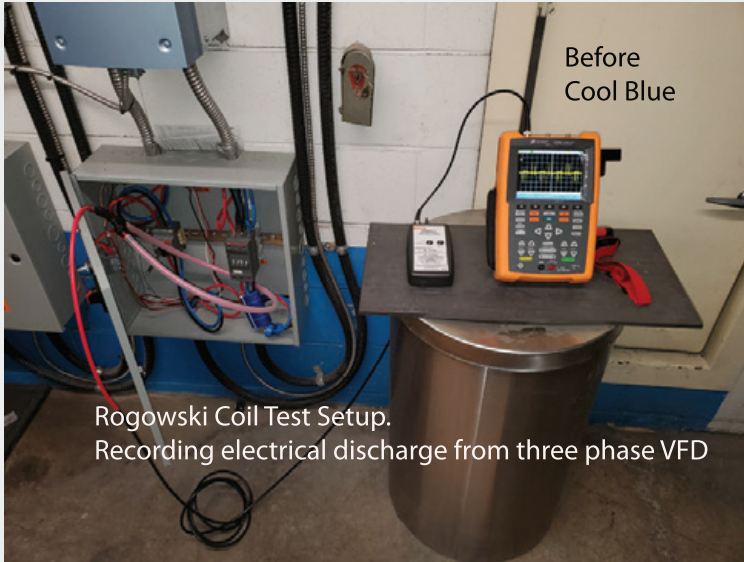
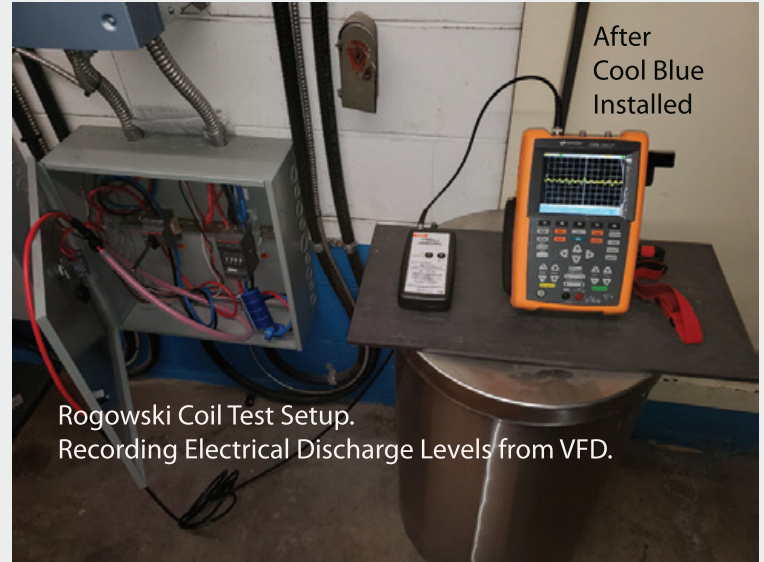
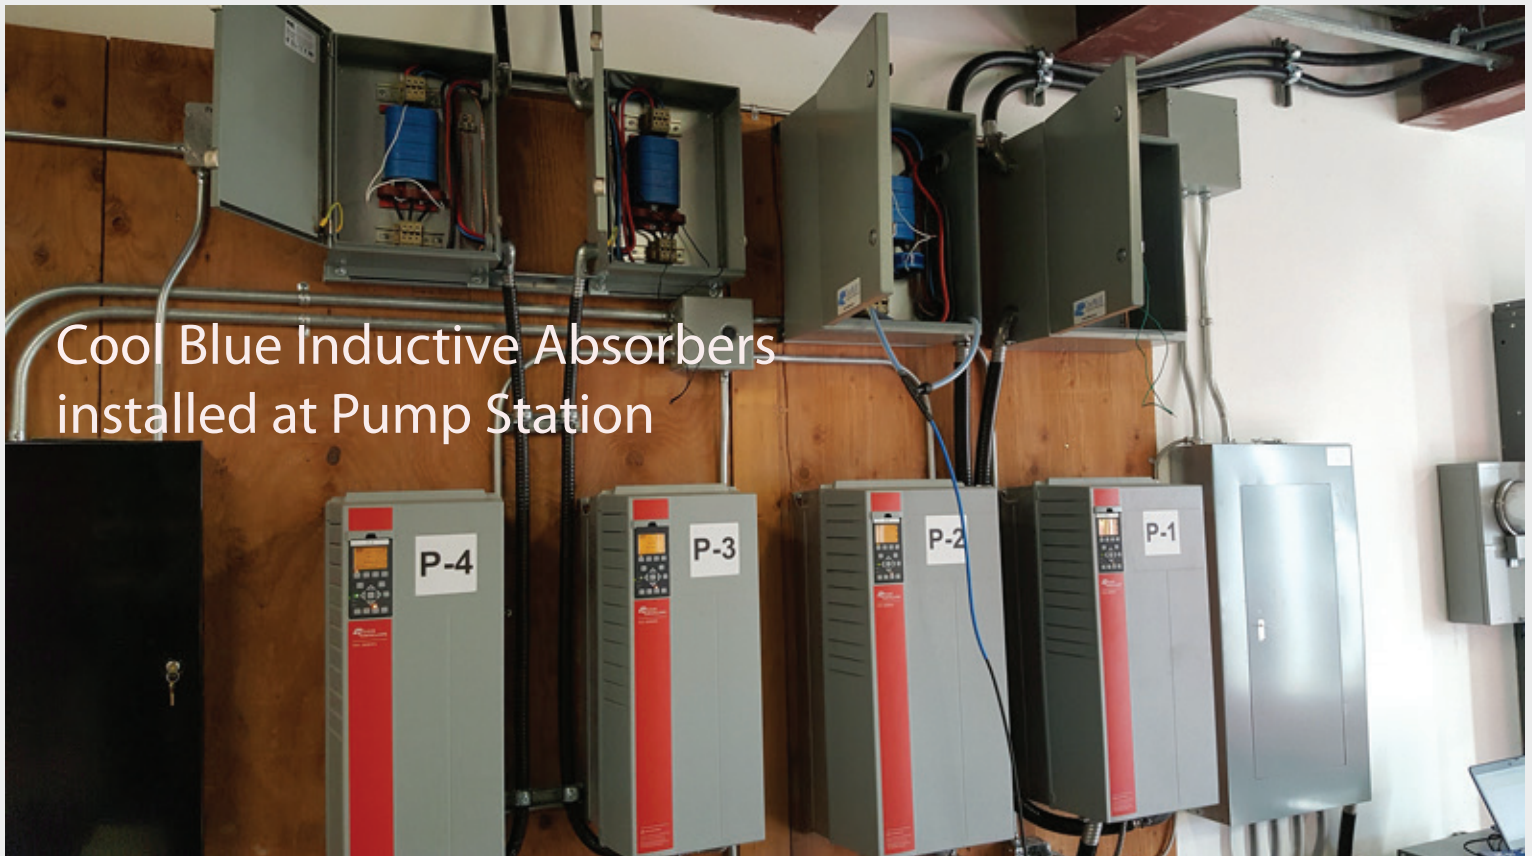
**CoolBLUE® Inductive Absorbers**

Absorb the energy caused by the VFD'S at the source...before getting the motor.

Elimination of Shaft Currents that were causing consistent motor bearing failures at this site.

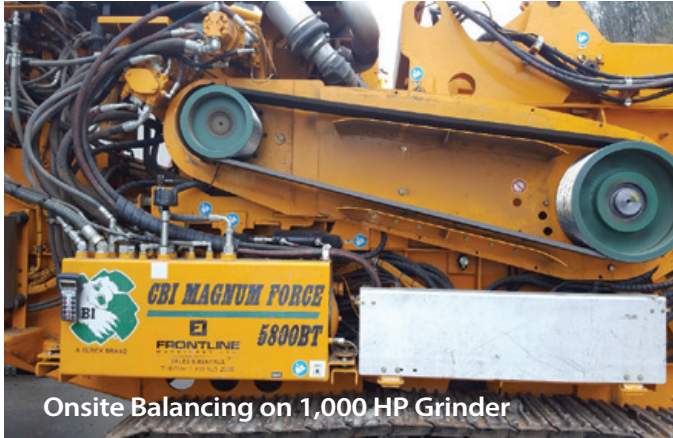
Onsite Balancing on 1,000 HP Grinder

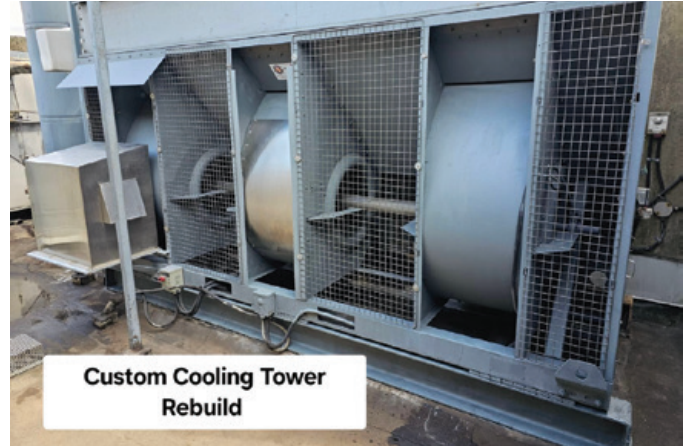
Custom Cooling Tower Rebuild

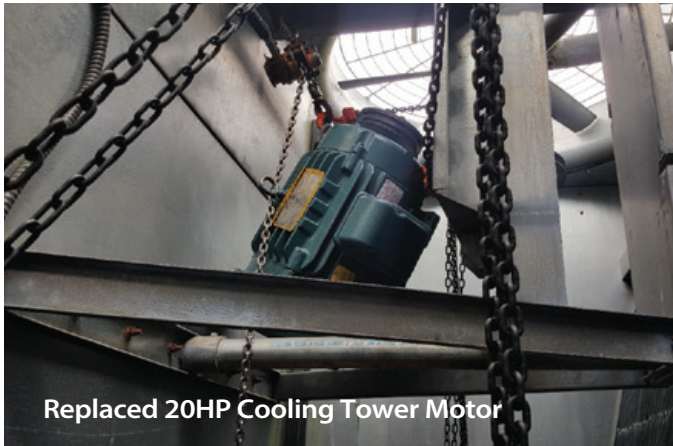
Replaced 20HP Cooling Tower Motor

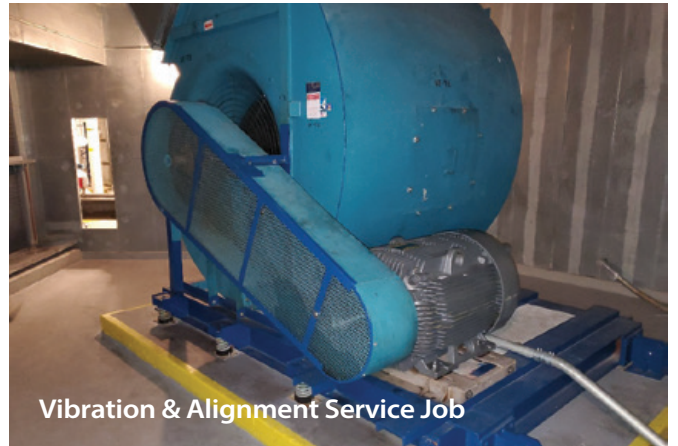
Vibration & Alignment Service Job

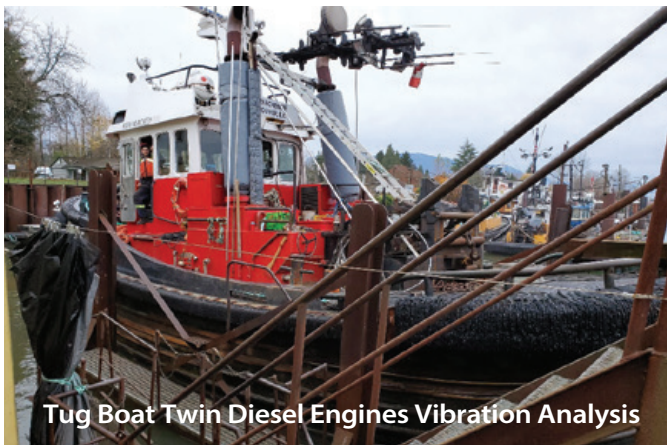
Tug Boat Twin Diesel Engines Vibration Analysis

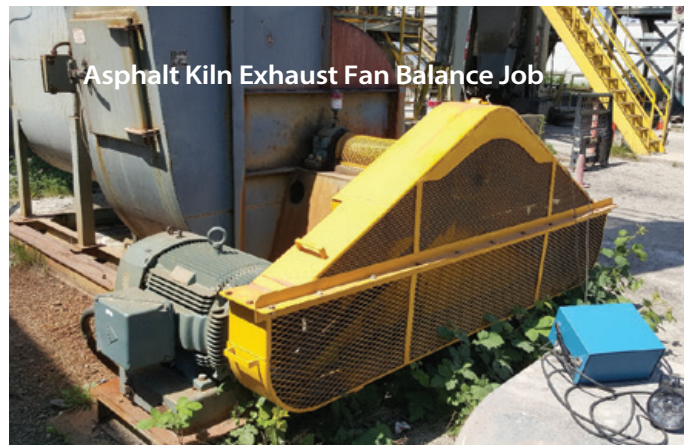
Asphalt Kiln Exhaust Fan Balance Job

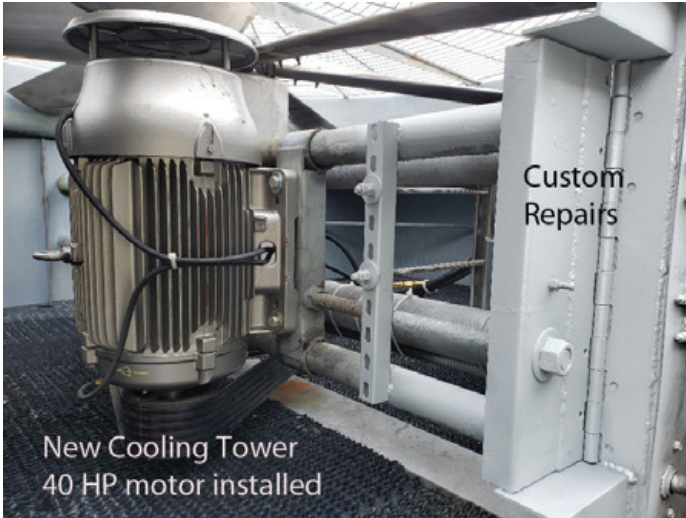
New Cooling Tower  
40 HP motor installed

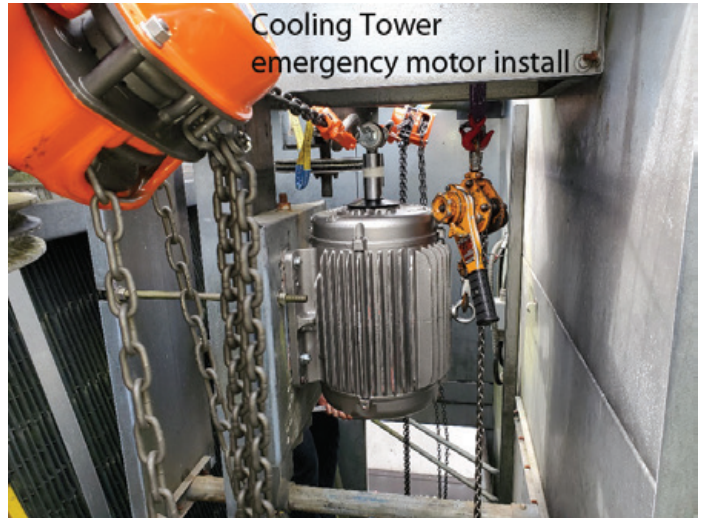
Cooling Tower  
emergency motor install

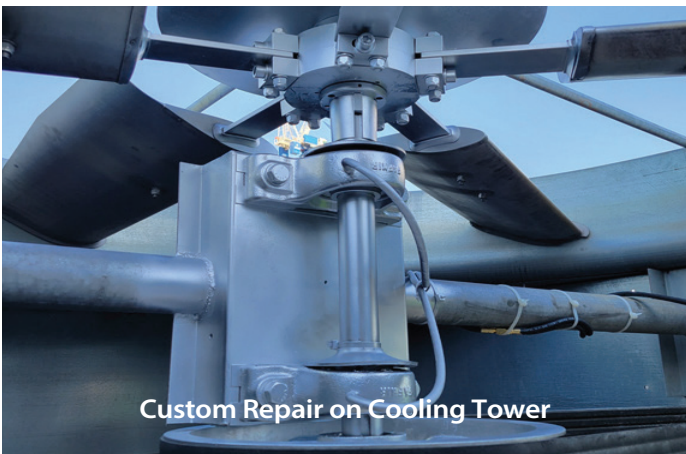
Custom Repair on Cooling Tower

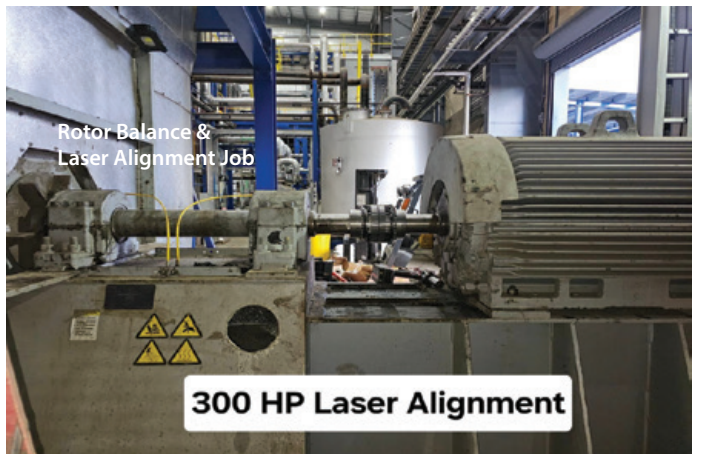
Rotor Balance &  
Laser Alignment Job

300 HP Laser Alignment

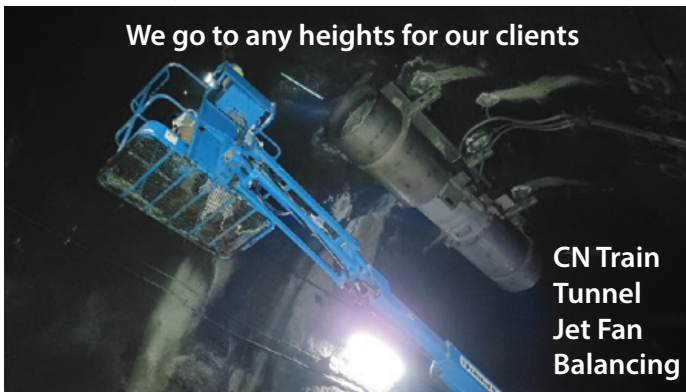
CN Train  
Tunnel  
Jet Fan  
Balancing

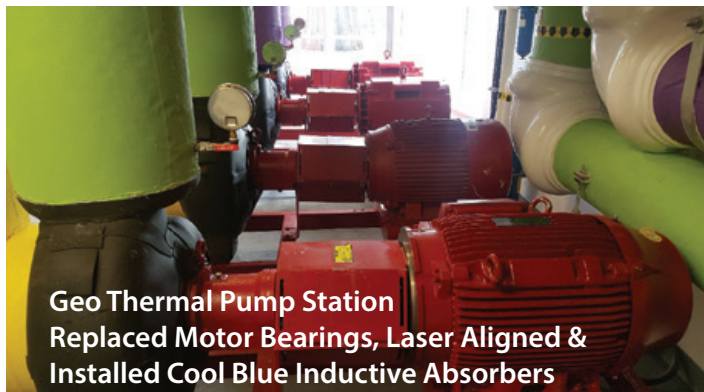
Geo Thermal Pump Station  
Replaced Motor Bearings, Laser Aligned &  
Installed Cool Blue Inductive Absorbers

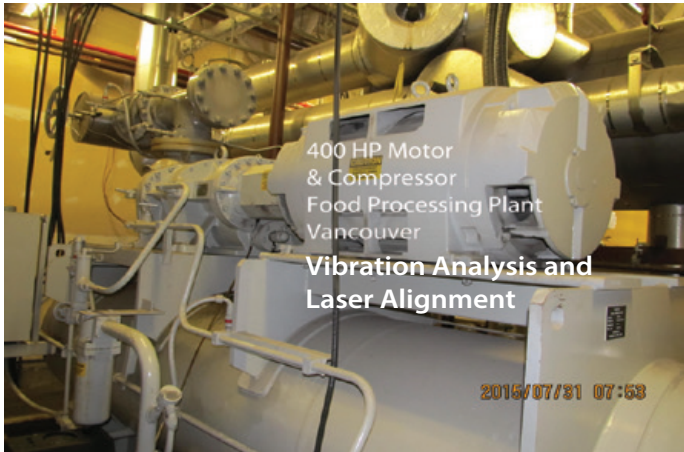
400 HP Motor & Compressor  
Food Processing Plant  
Vancouver  
Vibration Analysis and  
Laser Alignment

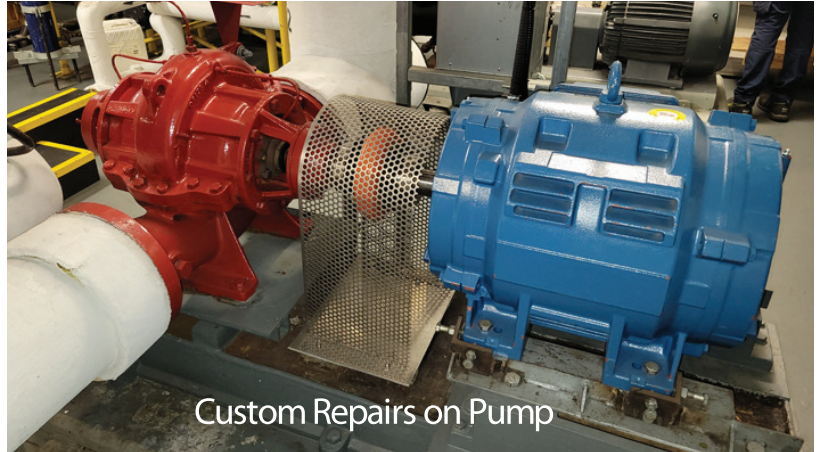
Custom Repairs on Pump

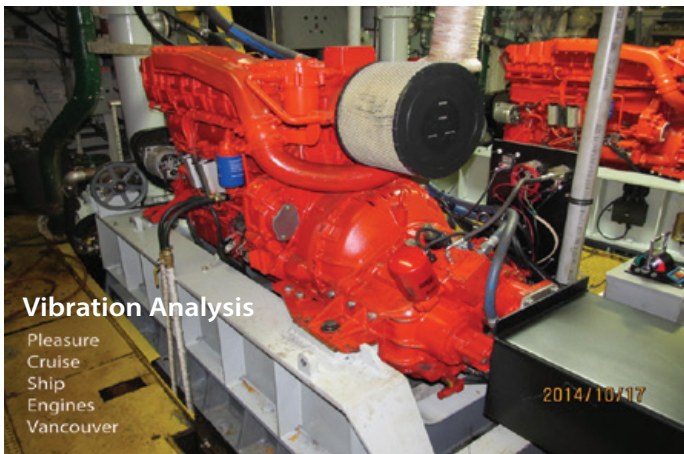
Vibration Analysis

Pleasure  
Cruise  
Ship  
Engines  
Vancouver

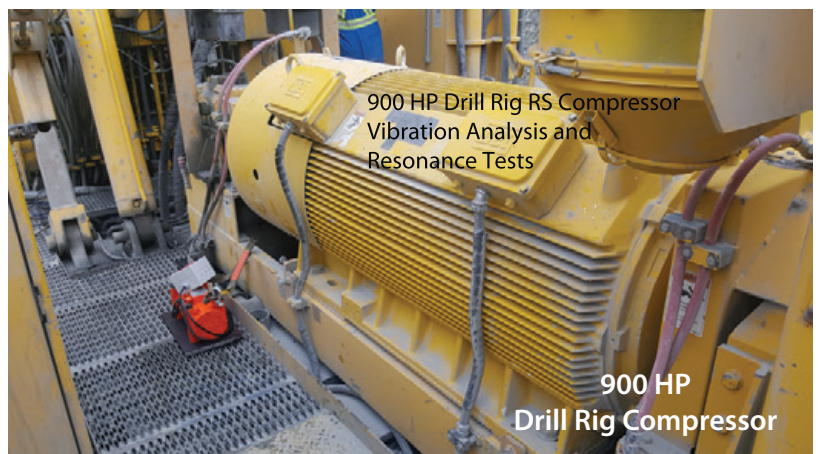
900 HP Drill Rig RS Compressor  
Vibration Analysis and  
Resonance Tests

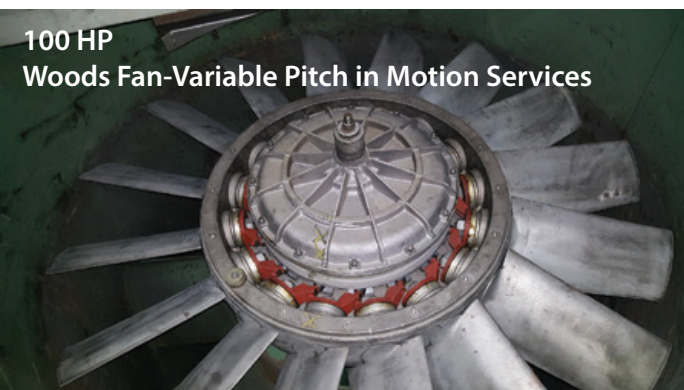
100 HP  
Woods Fan-Variable Pitch in Motion Services

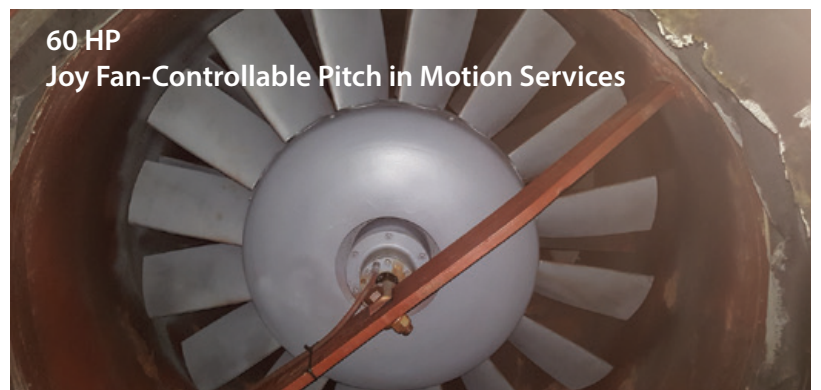
60 HP  
Joy Fan-Controllable Pitch in Motion Services

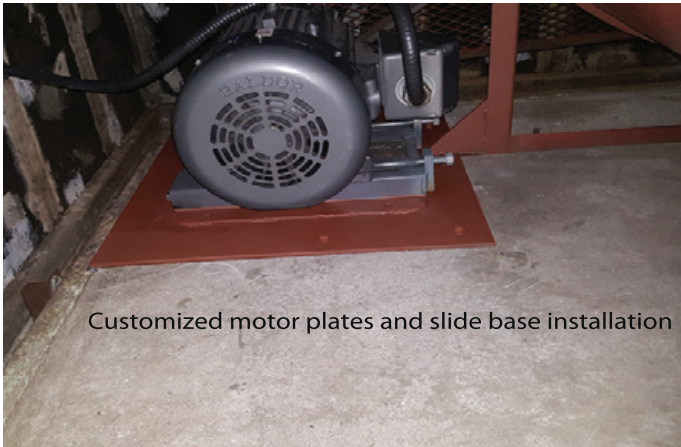
Customized motor plates and slide base installation

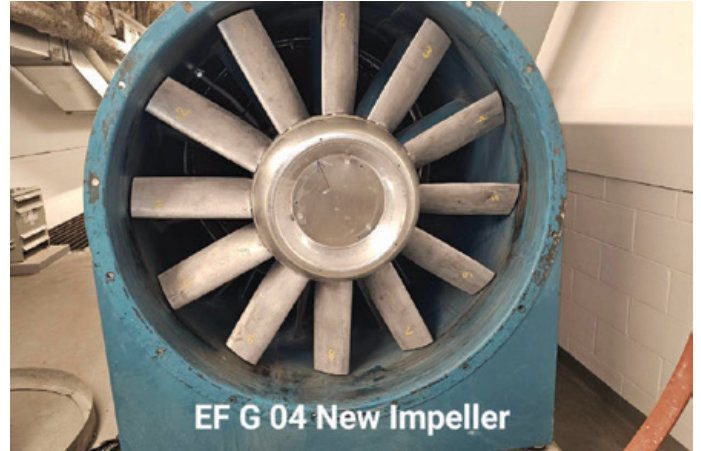
EF G 04 New Impeller

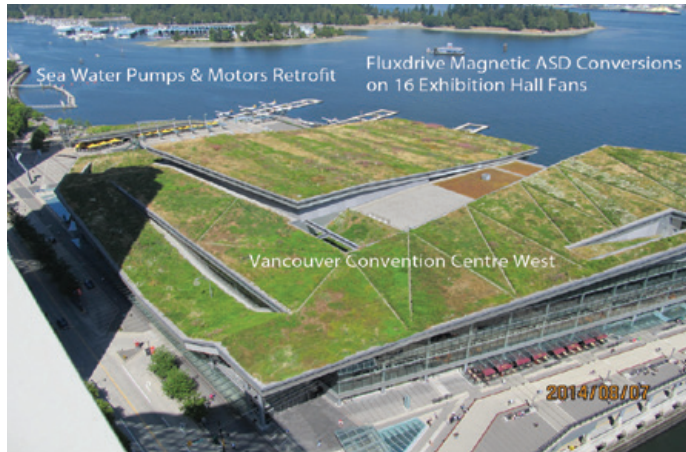
Sea Water Pumps & Motors Retrofit

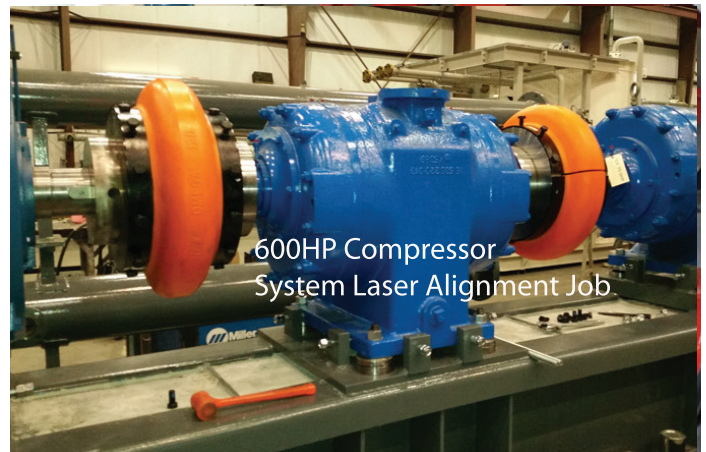
600HP Compressor System Laser Alignment Job

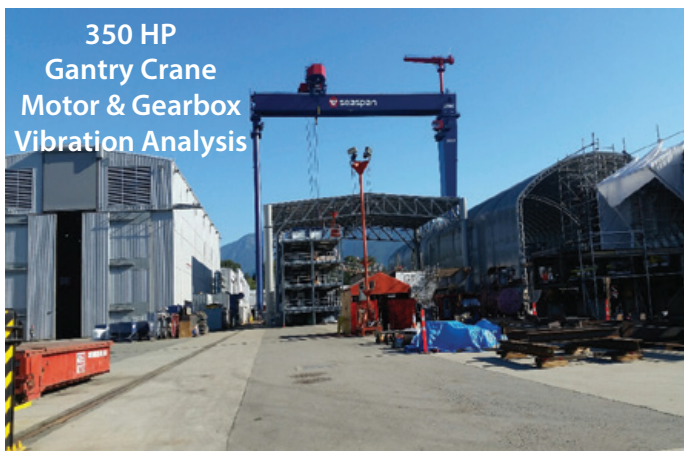
350 HP Gantry Crane Motor & Gearbox Vibration Analysis

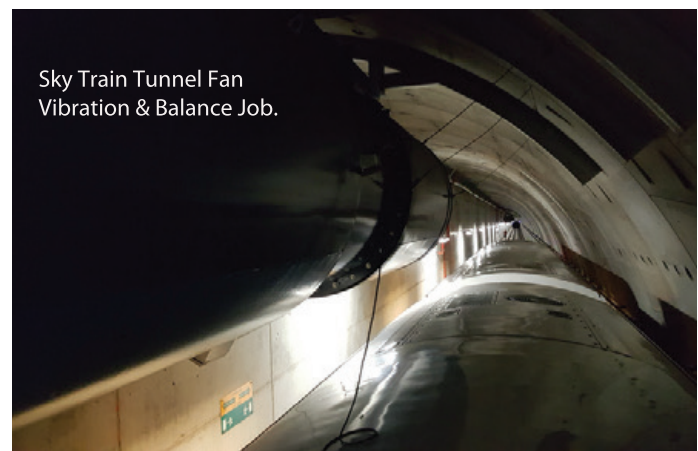
Sky Train Tunnel Fan Vibration & Balance Job.

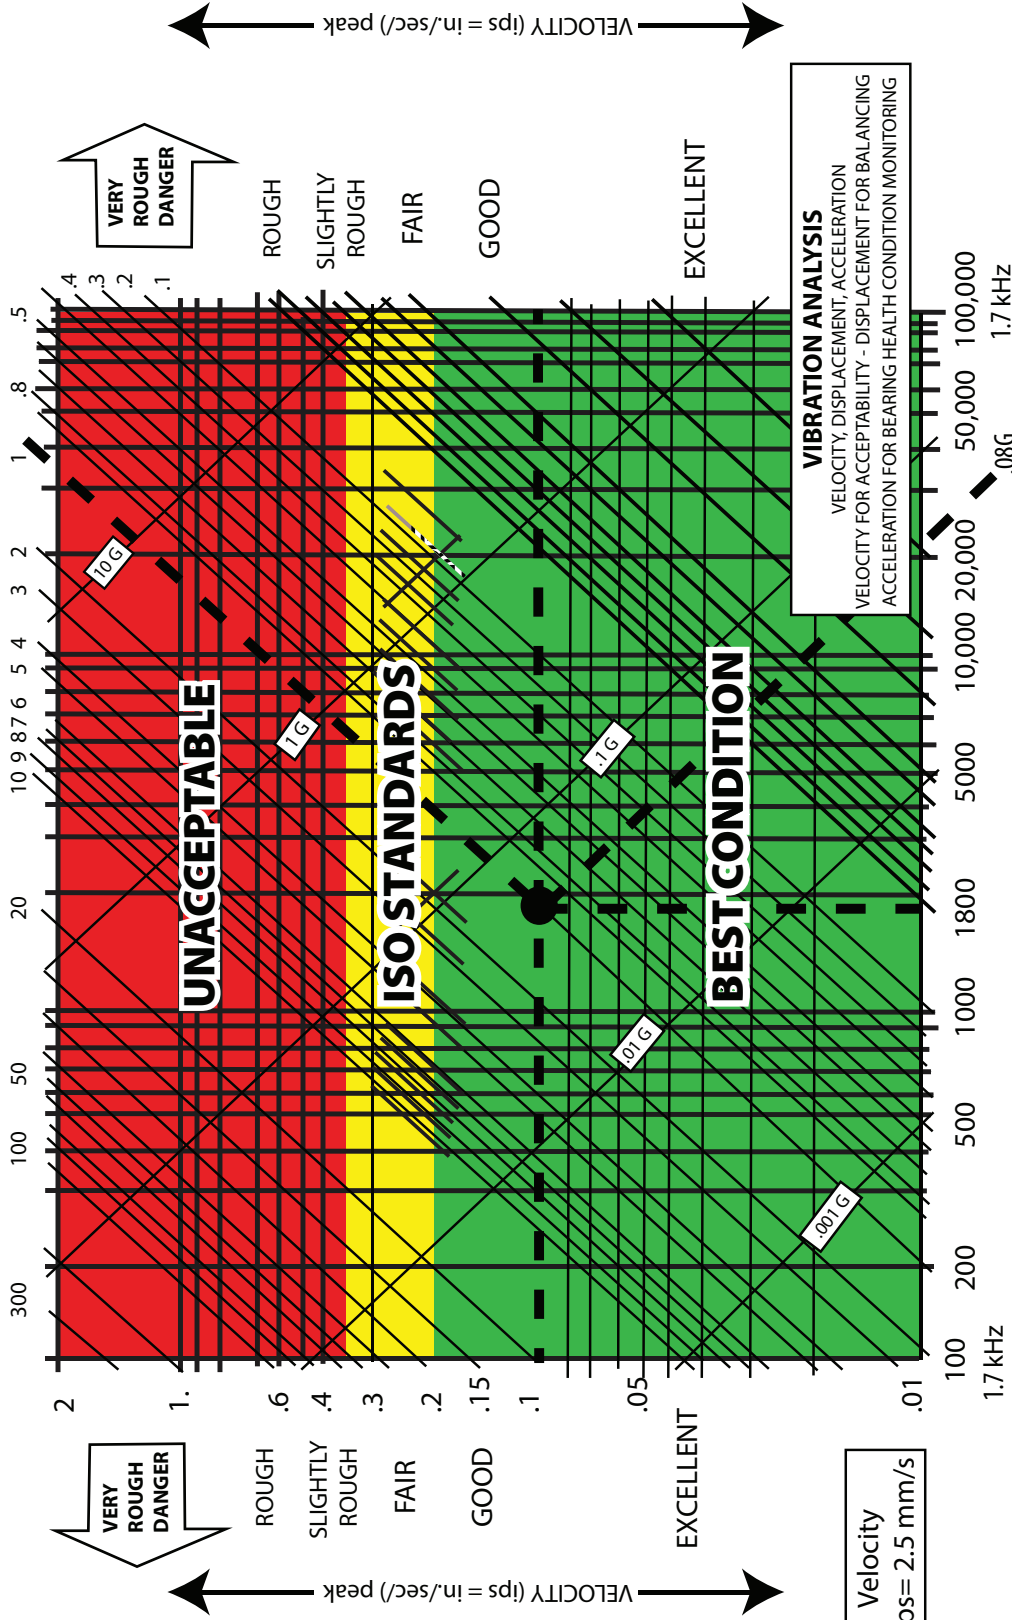
**VIBRATION SEVERITY GRAPH FOR GENERAL ROTATING MACHINERY**

This Chart is based on ISO 10816-3

Displacement  
1 mil = 25 microns

DISPLACEMENT Mils (x.001") peak to peak

**VIBRATION ANALYSIS**  
VELOCITY, DISPLACEMENT, ACCELERATION  
VELOCITY FOR ACCEPTABILITY - DISPLACEMENT FOR BALANCING  
ACCELERATION FOR BEARING HEALTH CONDITION MONITORING

**REFERENCE POINT ●** = 1800 rpm machine/ motor excellent condition

ACCELERATION or FORCE OF GRAVITY "G" (ips<sup>2</sup> = in./sec<sup>2</sup> for simplicity)  
ACTUAL G = 32 fps/s = 9.8 m/s/s

Note: the yellow area on chart represents issues that often can't be resolved due to time and cost.
