SERIOUS SERVICE®
(Fan Doctor®)

Vibration Industrial Balancing & Equipment Services, Corporation
720 - 999 W. Broadway, Vancouver, BC V5Z 1K5
www.vibescorp.ca email: info@vibescorp.ca
Phone: 604 - 619 - 9381 (24/7)

The photos below show typical projects that we have completed.

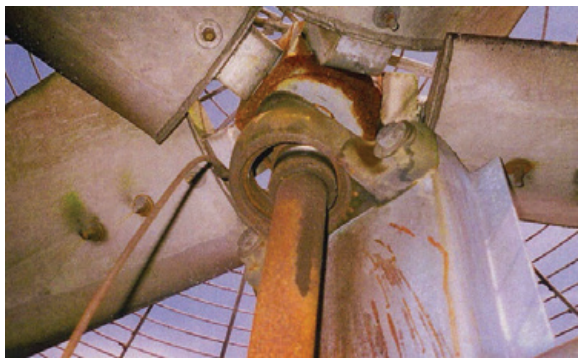
Fig 1. The failure was due to defective bearing.

Solution to Fig. 1 Replaced both Fan Bearings & New Motor Required.

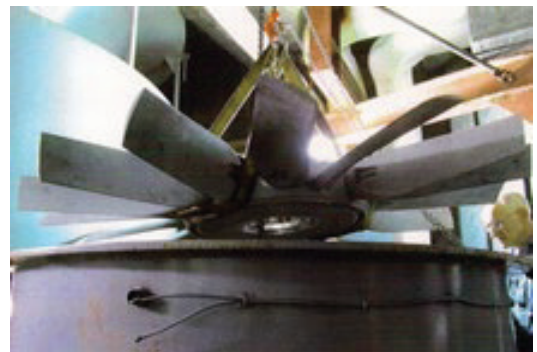
Fig 4. Shows a 200HP motor and fan repair/replacement.

Solution to Fig. 4 Replaced the Old Motor based on 20 years of running time and Completed Variable Pitch in Motion Fan Maintenance.

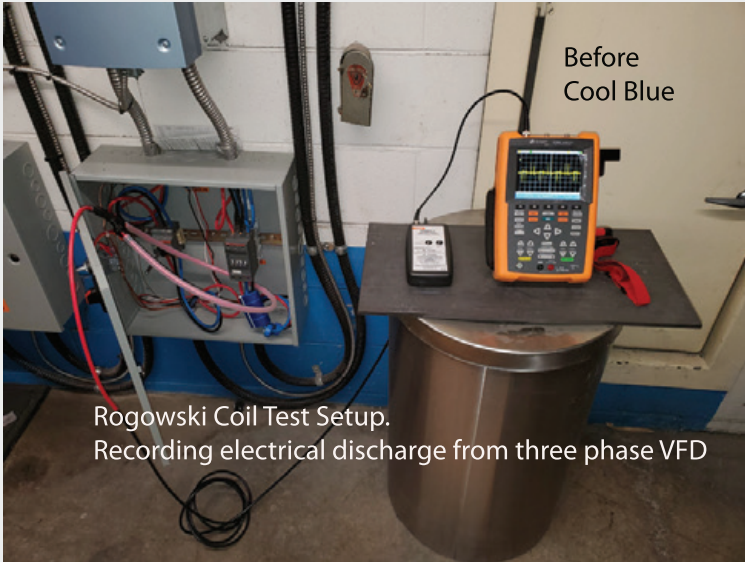
Elimination of Shaft Currents that were causing consistent motor bearing failures at this site.

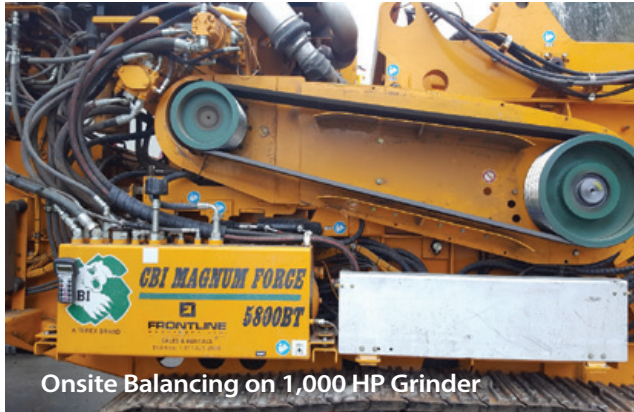
Onsite Balancing on 1,000 HP Grinder

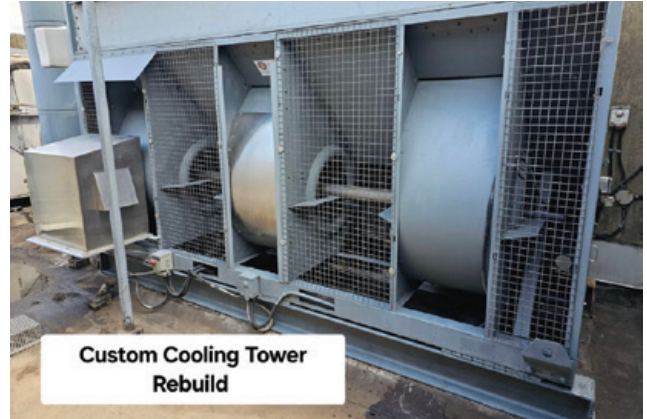
Custom Cooling Tower Rebuild

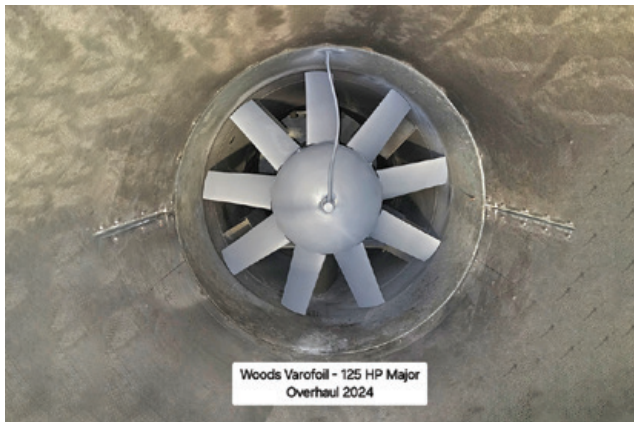
Woods Varofoil - 125 HP Major Overhaul 2024

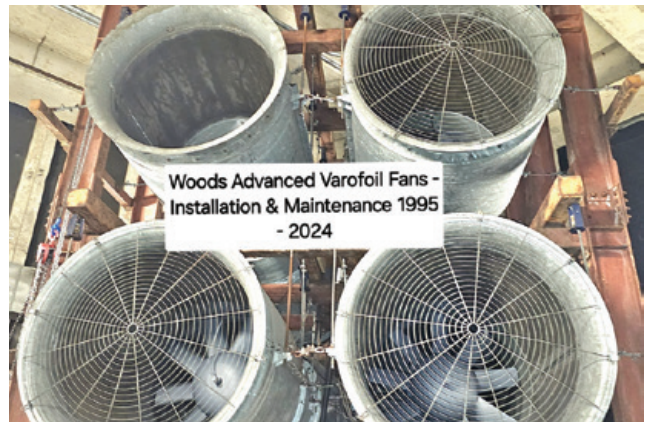
Woods Advanced Varofoil Fans - Installation & Maintenance 1995 - 2024

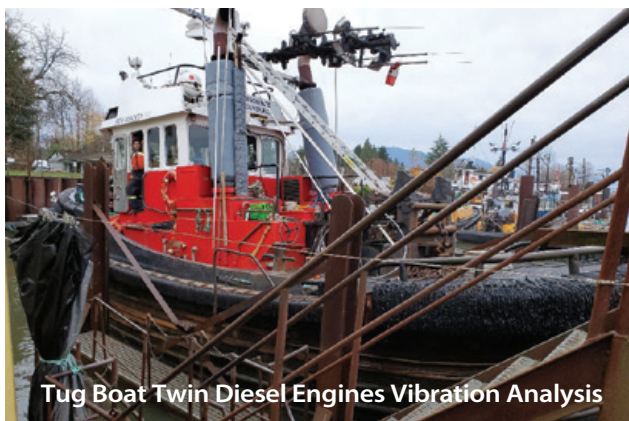
Tug Boat Twin Diesel Engines Vibration Analysis

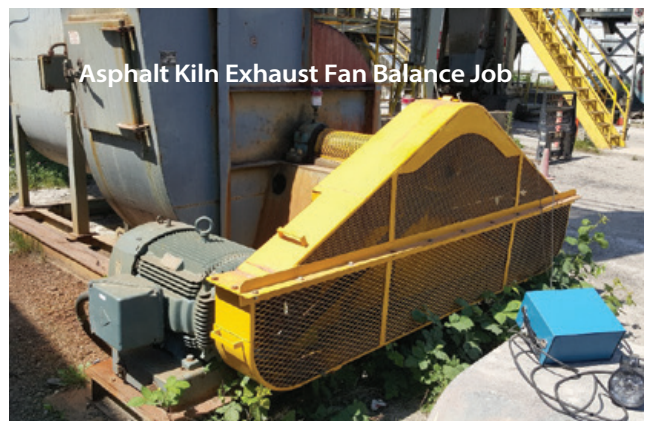
Asphalt Kiln Exhaust Fan Balance Job

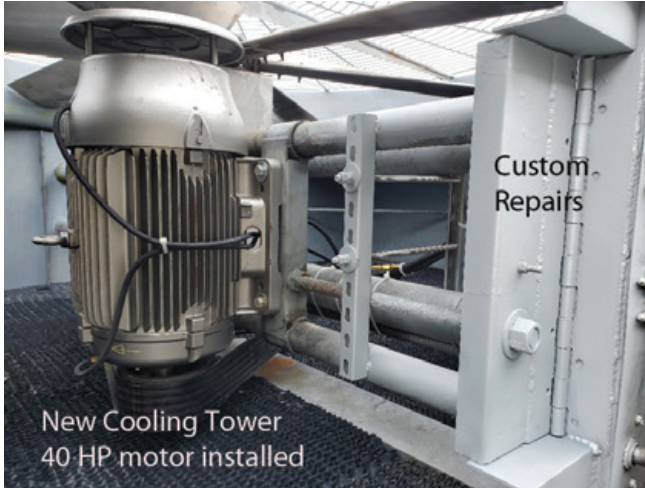
New Cooling Tower
40 HP motor installed

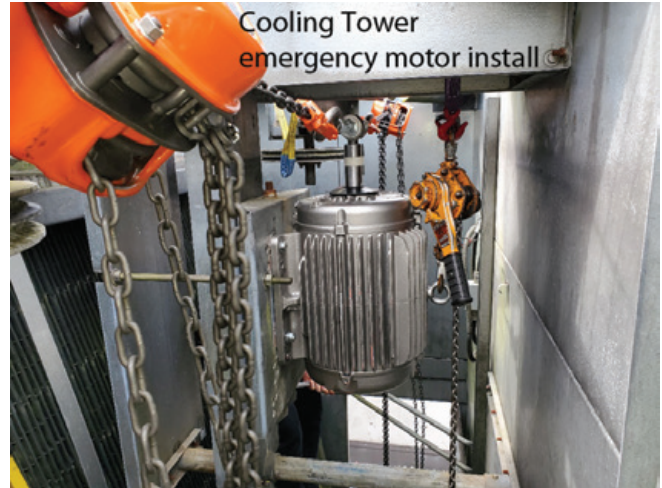
Cooling Tower
emergency motor install

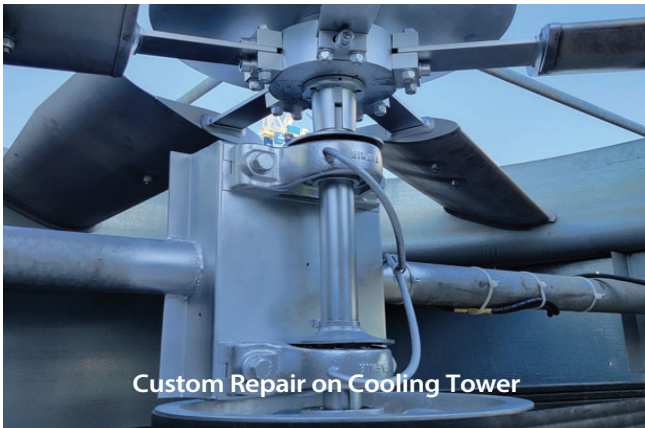
Custom Repair on Cooling Tower

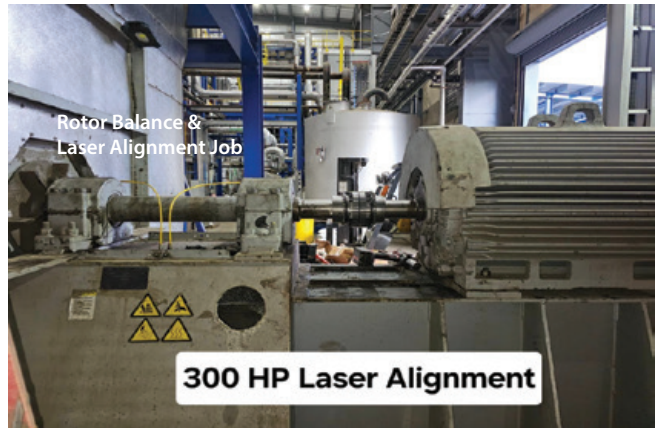
Rotor Balance &
Laser Alignment Job

300 HP Laser Alignment

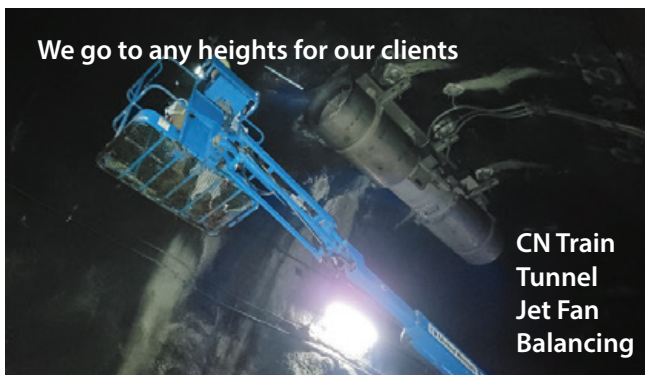
CN Train
Tunnel
Jet Fan
Balancing

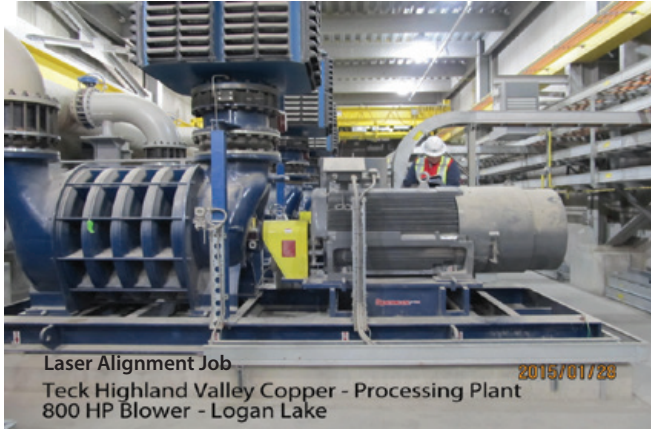
Laser Alignment Job
Teck Highland Valley Copper - Processing Plant
800 HP Blower - Logan Lake
2015/01/28

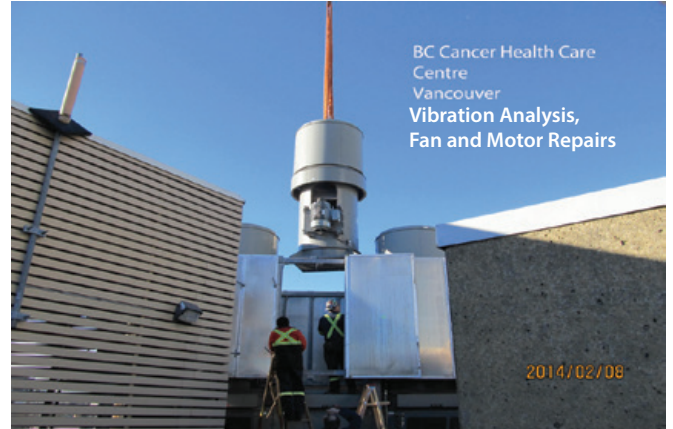
BC Cancer Health Care
Centre
Vancouver
Vibration Analysis,
Fan and Motor Repairs

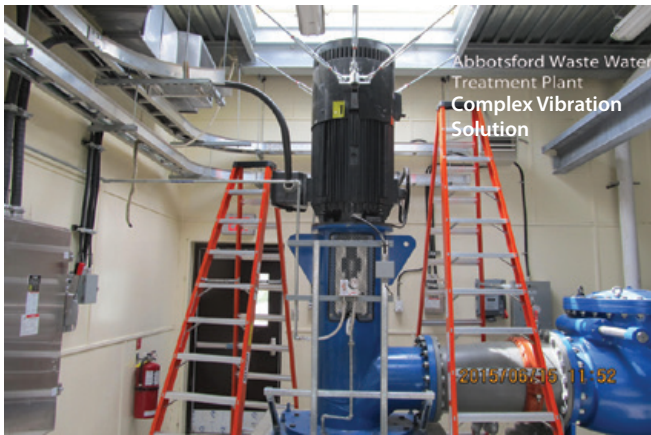
Abbotsford Waste Water
Treatment Plant
Complex Vibration
Solution

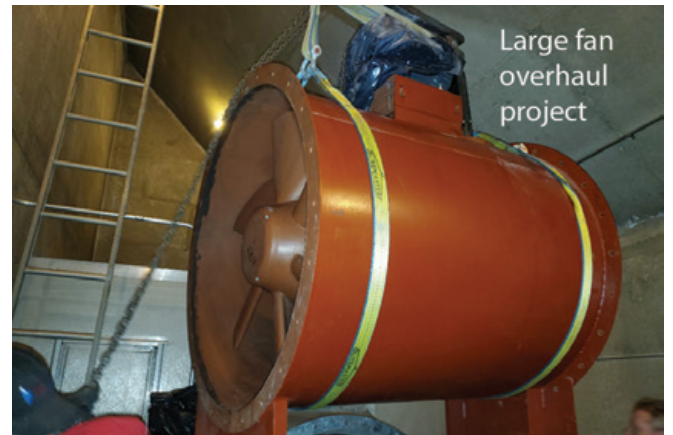
Large fan
overhaul
project

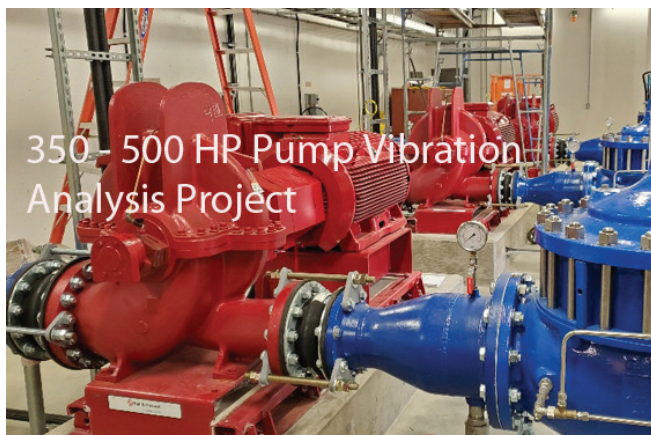
350 - 500 HP Pump Vibration
Analysis Project

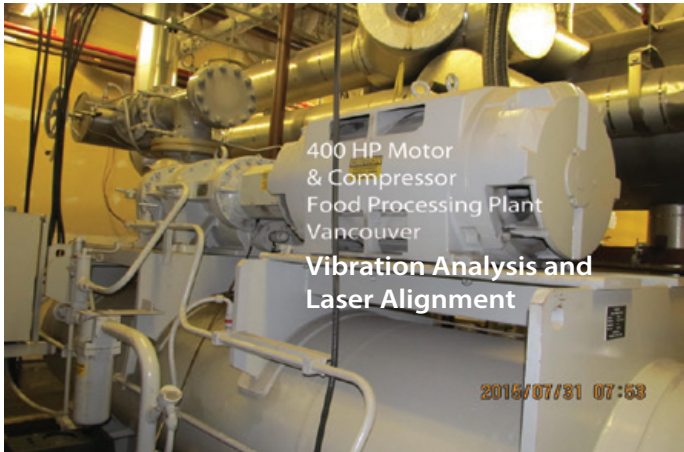
400 HP Motor
& Compressor
Food Processing Plant
Vancouver
Vibration Analysis and
Laser Alignment

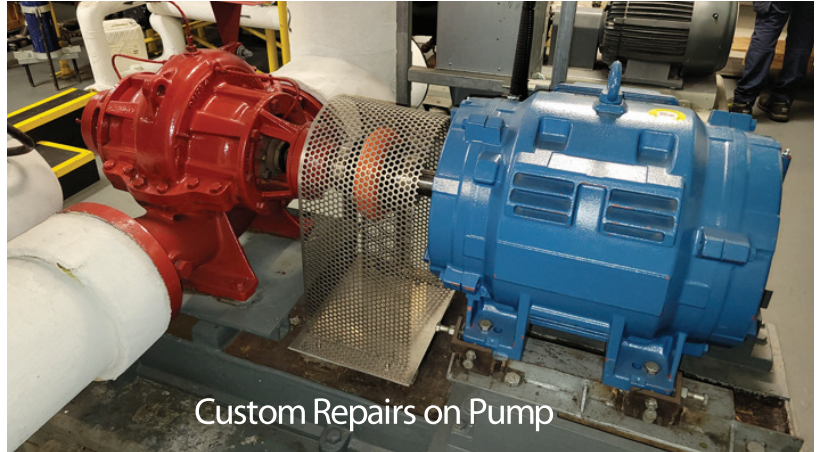
Custom Repairs on Pump

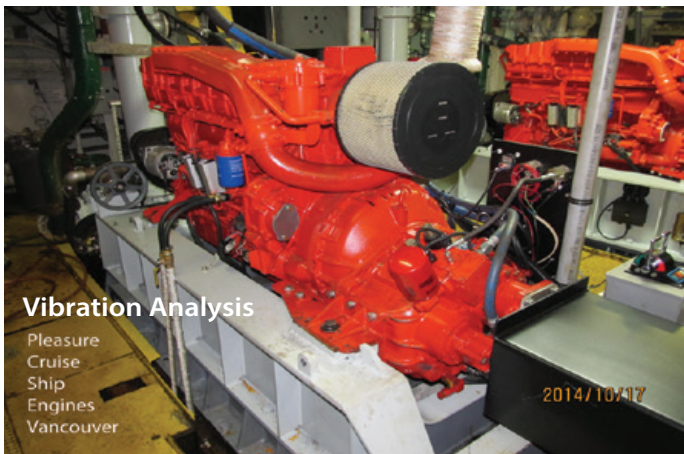
Vibration Analysis

Pleasure
Cruise
Ship
Engines
Vancouver

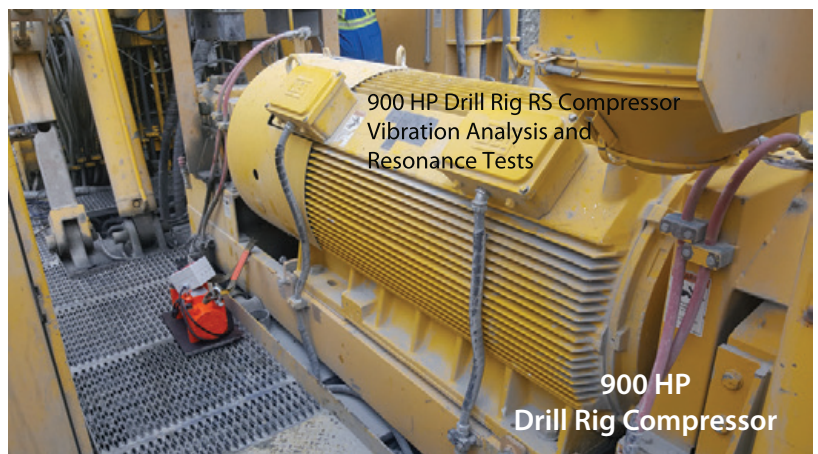
900 HP Drill Rig RS Compressor
Vibration Analysis and
Resonance Tests

900 HP
Drill Rig Compressor

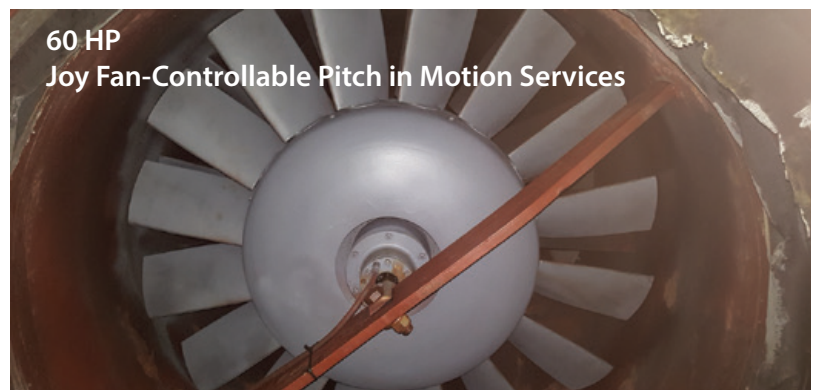
60 HP
Joy Fan-Controllable Pitch in Motion Services

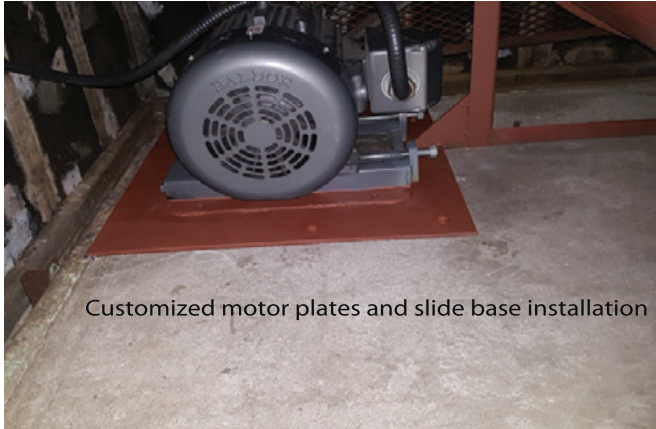
Customized motor plates and slide base installation

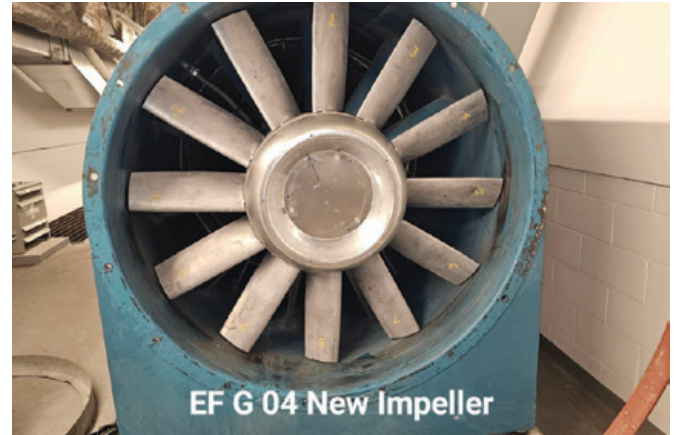
EF G 04 New Impeller

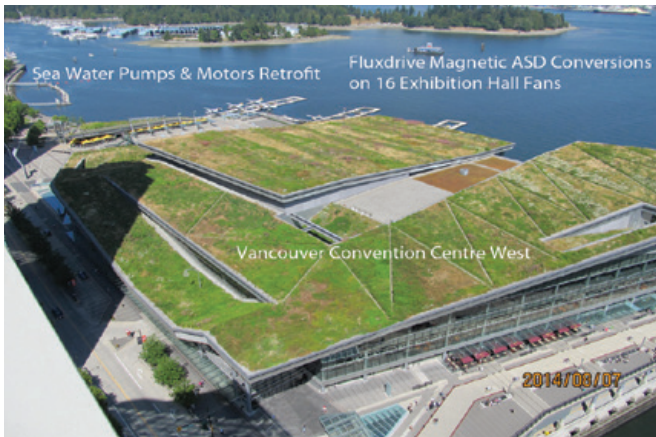
Sea Water Pumps & Motors Retrofit Fluxdrive Magnetic ASD Conversions on 16 Exhibition Hall Fans

Vancouver Convention Centre West

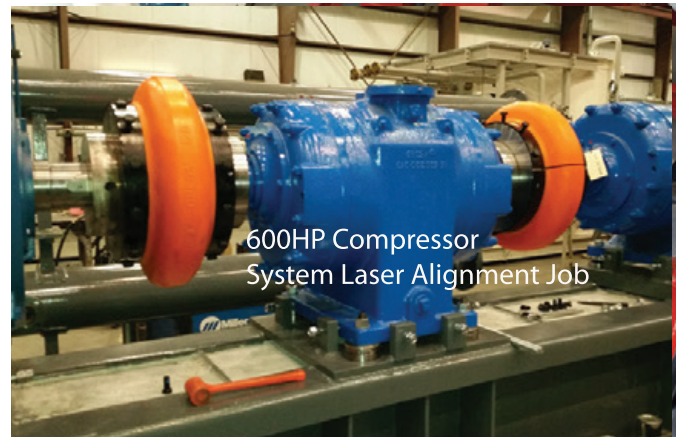
600HP Compressor System Laser Alignment Job

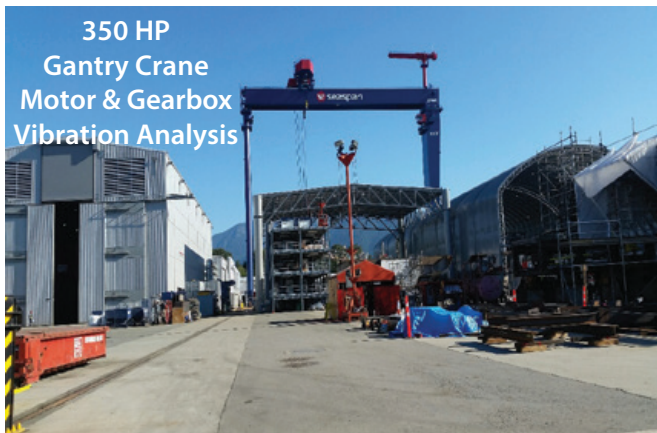
350 HP Gantry Crane Motor & Gearbox Vibration Analysis

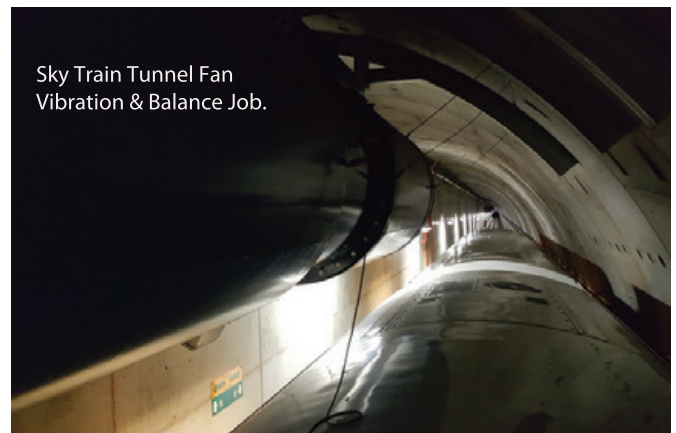
Sky Train Tunnel Fan Vibration & Balance Job.

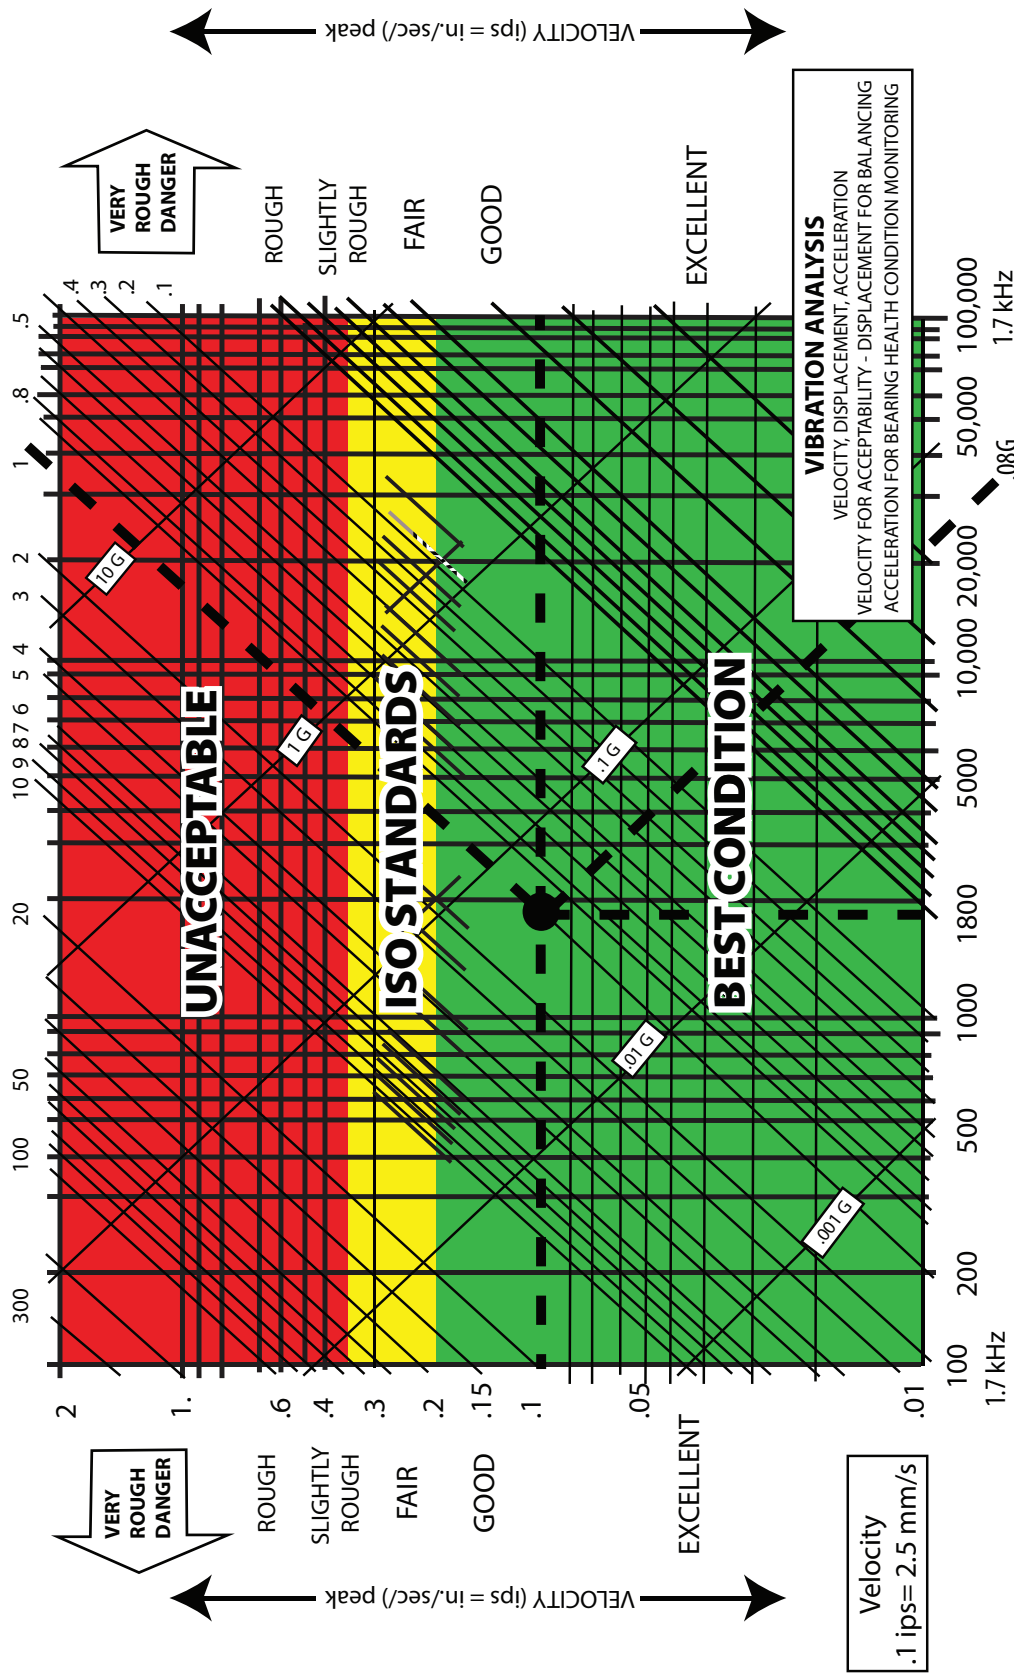
VIBRATION SEVERITY GRAPH FOR GENERAL ROTATING MACHINERY

This Chart is based on ISO 10816-3

VIBRATION ANALYSIS
VELOCITY, DISPLACEMENT, ACCELERATION
VELOCITY FOR ACCEPTABILITY - DISPLACEMENT FOR BALANCING
ACCELERATION FOR BEARING HEALTH CONDITION MONITORING

REFERENCE POINT ● = 1800 rpm machine/ motor excellent condition

Note: the yellow area on chart represents issues that often can't be resolved due to time and cost.
