SERIOUS SERVICE®
(Fan Doctor®)

Introduction to **VIBES Corp.**[®]

Why work with us? Serving Canadian Industry for over 50 Years.

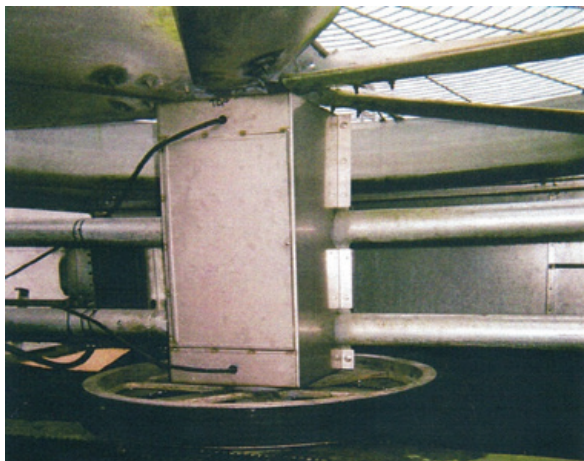
Fig 2. The stainless steel guard helps prevent moisture contamination in cooling tower fan bearings (a very common problem).

Solution to Fig. 2 The Guard has prolonged the Life Span of the Fan Bearings from 3 years to over 14 years.

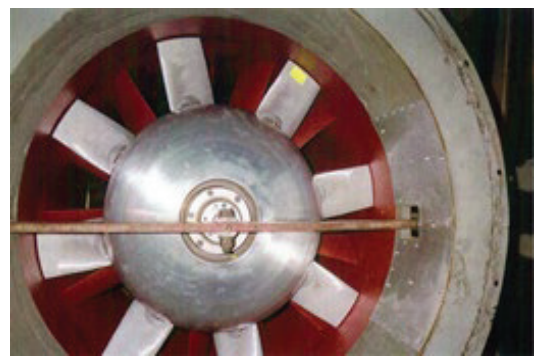
Fig 3. A new fan was installed due to a complete failure of the original.

Solution to Fig. 3 Installed Brand New Controllable Pitch Fan & Repaired Motor.

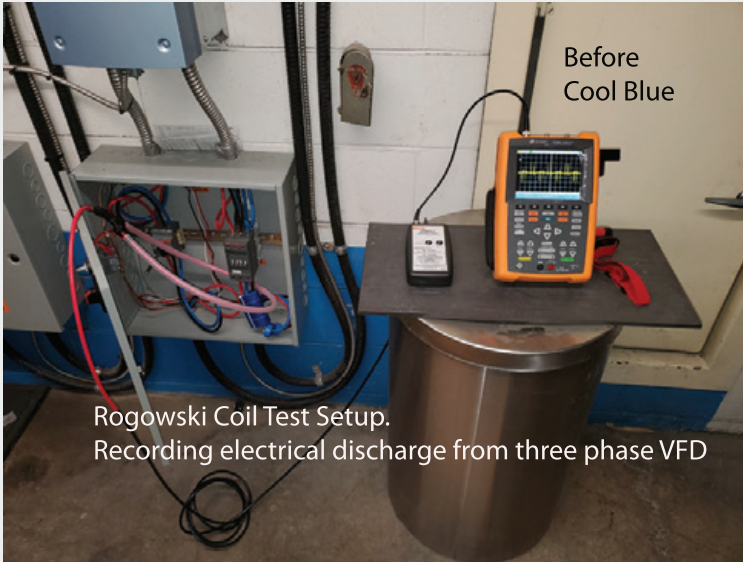
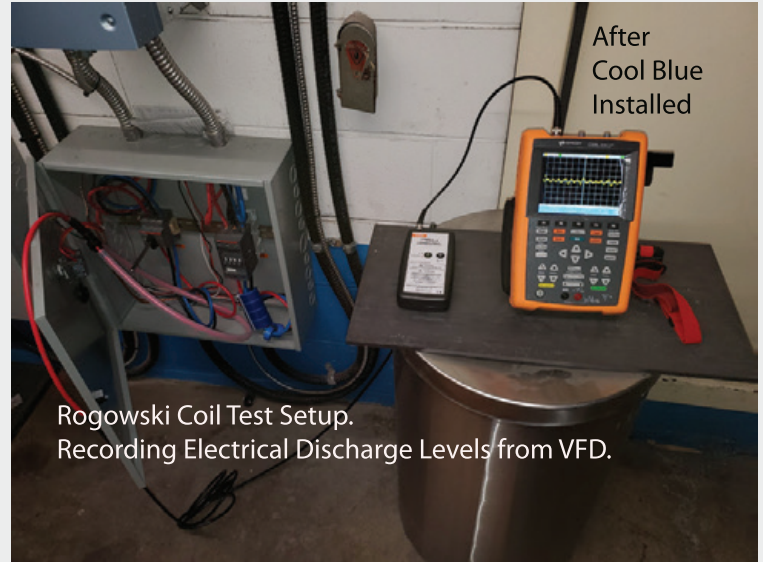
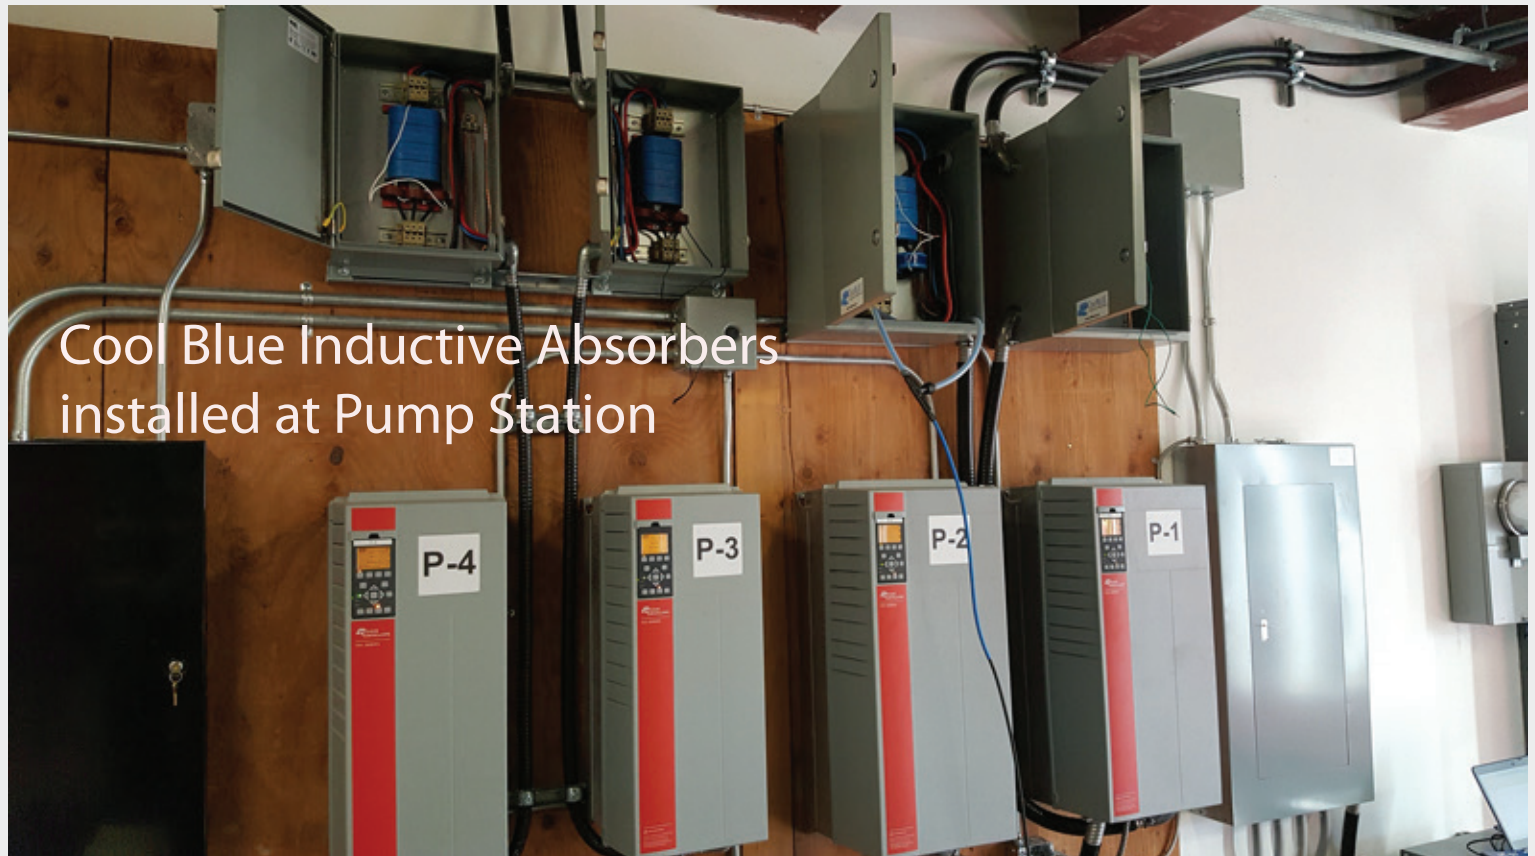
Absorb the energy caused by the VFD'S at the source...before getting to the motor bearings.

Elimination of Shaft Currents that were causing consistent motor bearing failures at this site.

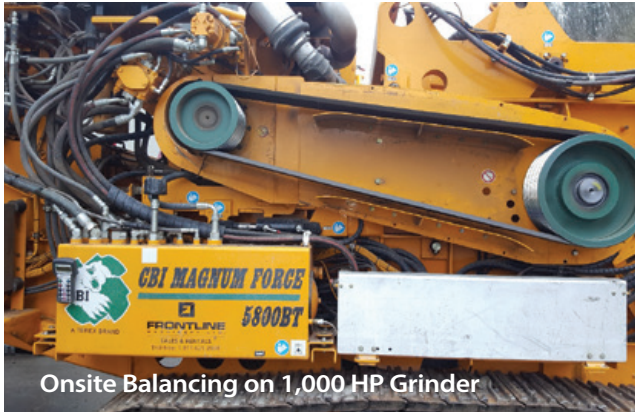
Onsite Balancing on 1,000 HP Grinder

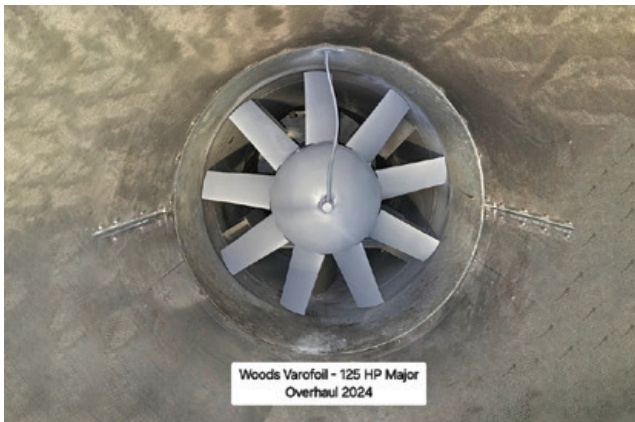
Woods Varofoil - 125 HP Major Overhaul 2024

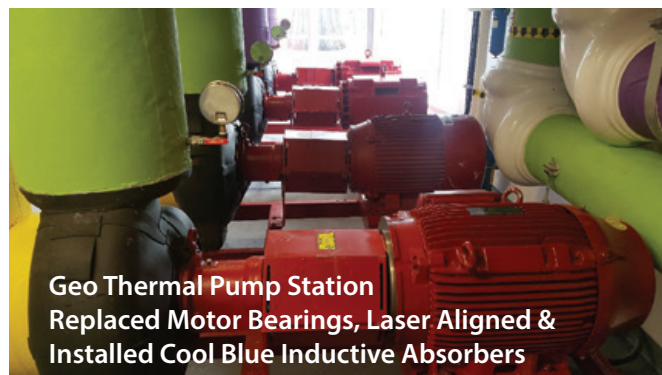
Geo Thermal Pump Station
Replaced Motor Bearings, Laser Aligned &
Installed Cool Blue Inductive Absorbers

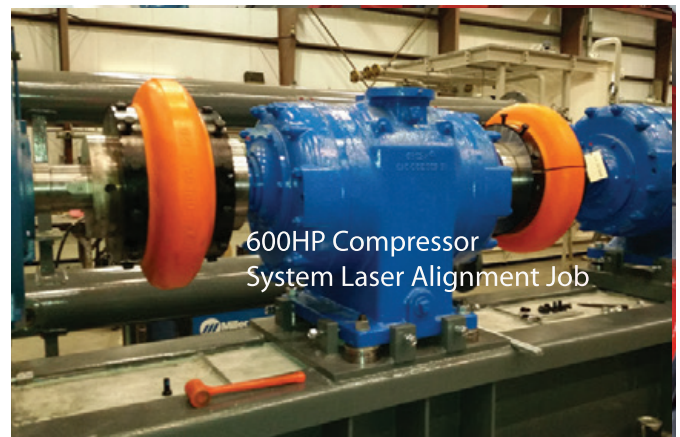
600HP Compressor System Laser Alignment Job

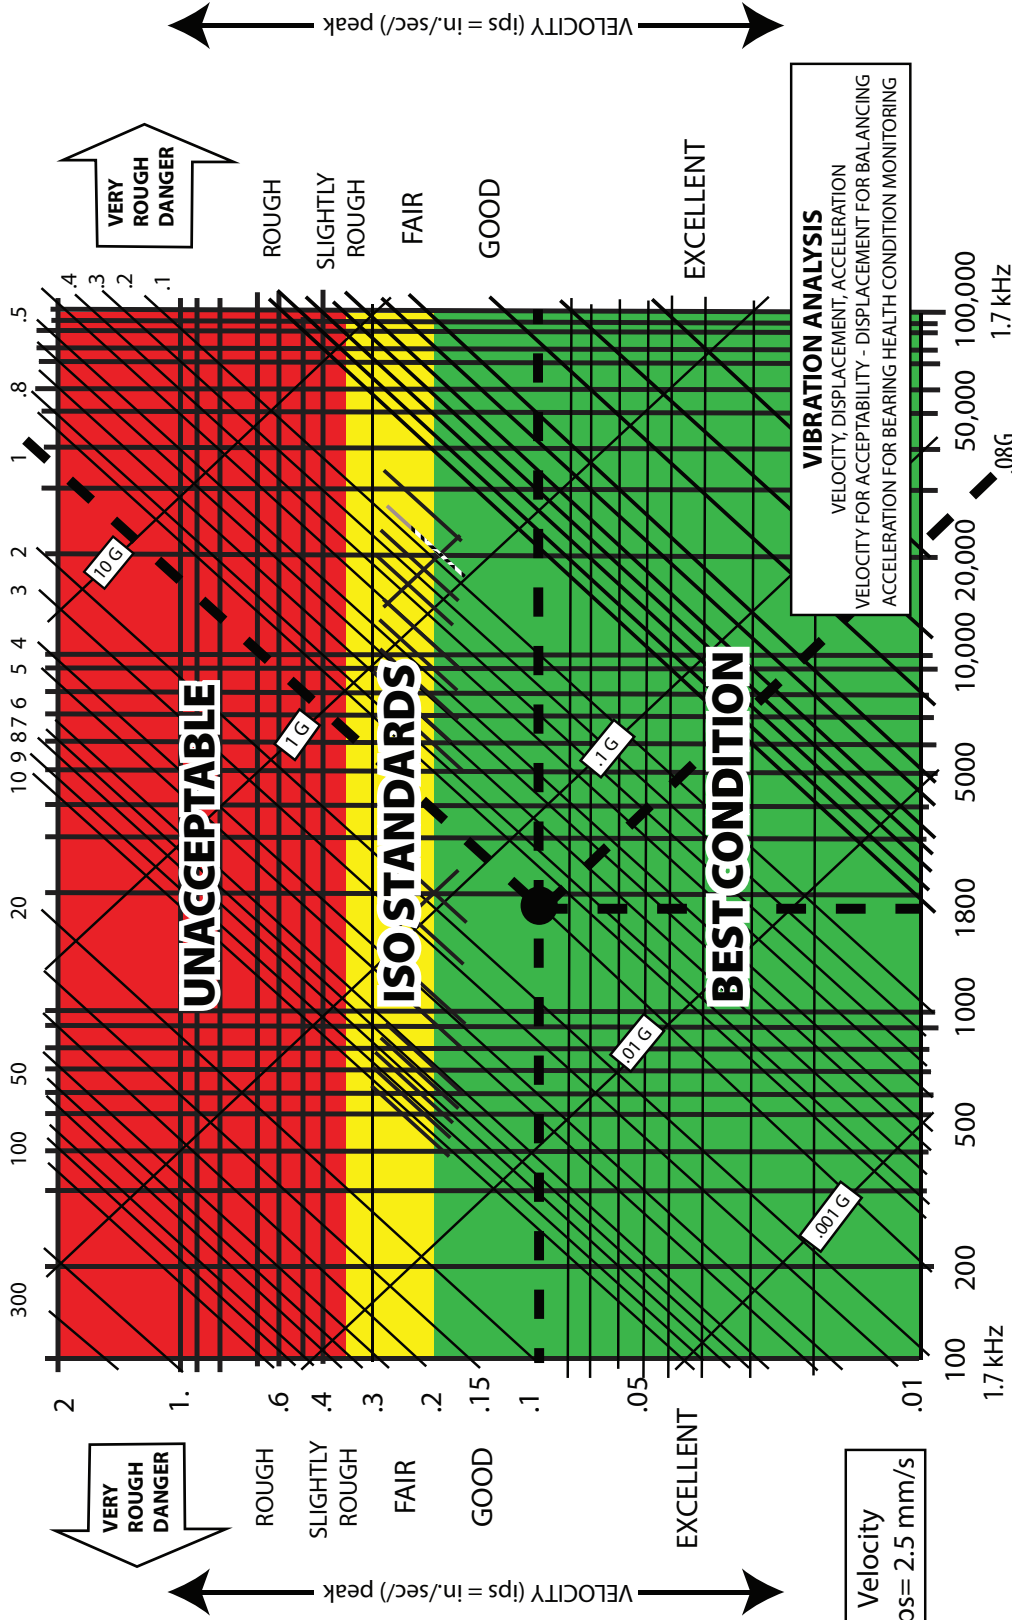
VIBRATION SEVERITY GRAPH FOR GENERAL ROTATING MACHINERY

This Chart is based on ISO 10816-3

VIBRATION ANALYSIS
VELOCITY, DISPLACEMENT, ACCELERATION
VELOCITY FOR ACCEPTABILITY - DISPLACEMENT FOR BALANCING
ACCELERATION FOR BEARING HEALTH CONDITION MONITORING

REFERENCE POINT ● = 1800 rpm machine/ motor excellent condition

Note: the yellow area on chart represents issues that often can't be resolved due to time and cost.
